**Dwight Schrute**  
4321 Dunder Dr.  
Dallas, TX 75223

**April 12, 2022**

# PROPERTY INSPECTION REPORT FORM

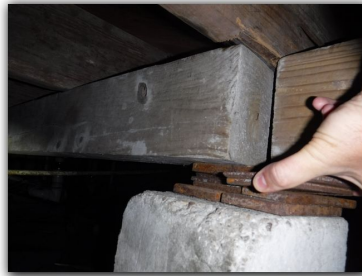
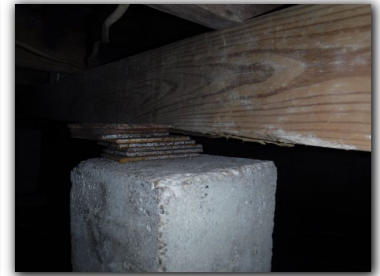
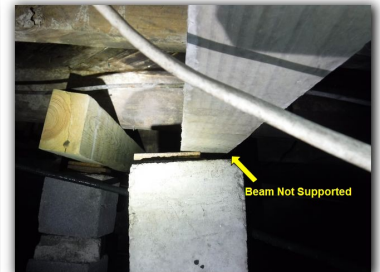
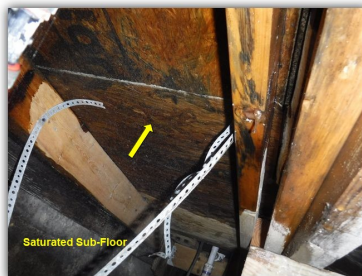
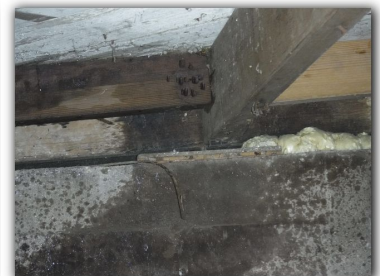
Some of the pier and beam foundation structural components appear to have deficiencies that are beyond normal. The Buyer should have the cause and remedy investigated by a foundation repair company familiar with pier and beam type structures. The observations made to support the rendering of this opinion are listed but may not be limited to the following:

- Leaning and vertically mis-aligned beam under living room area observed.
- One or more piers need shimming to make contact with beam above as gap was observed between pier and beam. Manually able to move piers below beams in one or more locations.
- The beam or floor joists below southeast wall (kitchen and dining area) are not properly supported, shims loose or beams/joists not bearing at least 3" on foundational wall.
- Moisture observed below guest bathroom and into master bathroom (North corner of home) due to leak in Pex line below. Recommend further evaluation or extend of any structural compromises as needed in this area.
- Larger than typical cracks in perimeter beam observed, most notably along SE wall.

- Stress crack(s) were observed in the exterior foundation perimeter beam. Recommend monitoring all cracks over time.
- Inadequate ventilation observed. Recommend improving venting of the crawl space as needed.

Crawl Space Ventilation: Does not meet today's standards, recommend evaluation and repair as needed by qualified/ licensed professional

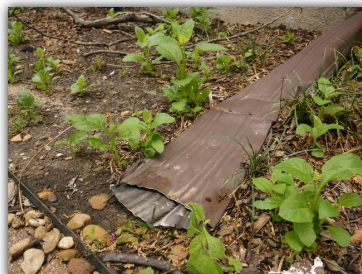
- Damaged or crushed downspout observed off front corner of home.

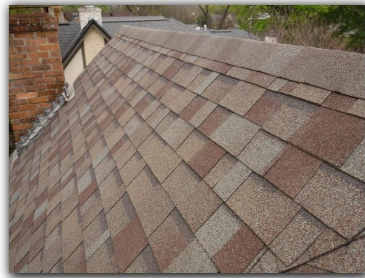
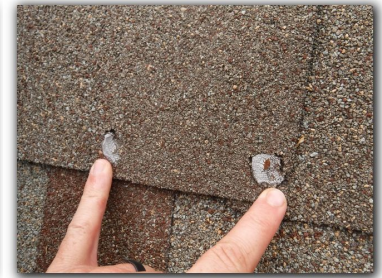
- One or more nail heads were observed to be exposed on roof covering. Recommend all exposed nail heads be sealed and protected from elements to prevent rust/deterioration.

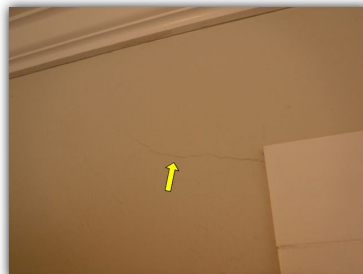
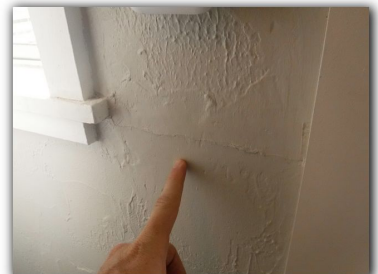
- **Notice:** Due to the home being occupied or staged, I was unable to inspect all of the interior surfaces because of window treatments, personalized wall treatments / finishes, personal effects, large, heavy or fragile storage and/or furniture.
- **Note:** There is evidence of painting and patching to the interior finish and prior interior finish repairs. This condition could limit the Inspectors visual observations and ability to render accurate opinions as to the performance of the structure. Recommend monitoring all signs of previous repair over time.
- Stress cracks observed in sheet rock/drywall in one or more areas of home, including (but may not be limited to) master bathroom entry, opening to dining area, and guest bathroom. Recommend monitoring all cracks over time or repairing as needed.

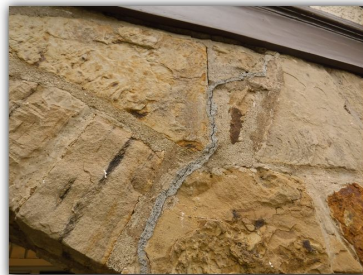
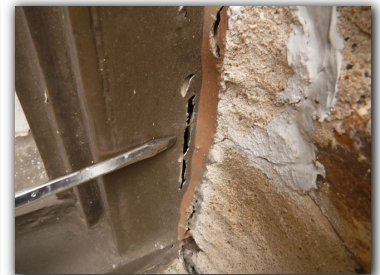
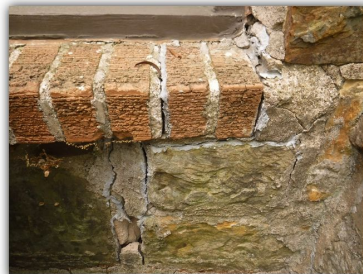
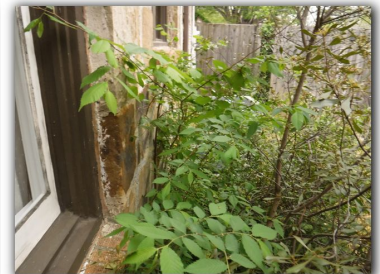
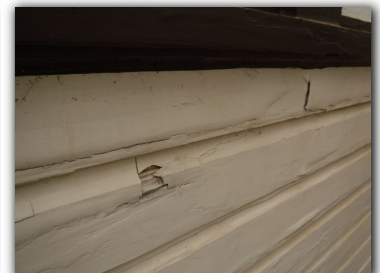
- **Note:** Signs of previous repair to mortar observed at one or more locations around home. Recommend monitoring all areas of previous repair over time.

- **Note:** Lead based paint testing is not performed and falls outside the scope of the general home inspection.
- Mortar cracks observed at one or more locations. Recommend monitoring all cracks over time or repairing (re-pointing) by qualified mason as needed.

- One or more mortar gaps observed at brick veneer. Recommend properly sealing off as needed by qualified mason.
- All wall penetrations such as wiring, receptacles, and meter boxes should be sealed where meeting wall.

- One or more portions of wood type siding members in need of re-painting or re-sealing to protect from elements.
- Loose stone off front door/porch observed.

- Caulking improvements are recommended for the area between the exterior veneer and the window frames. It is recommended to use elastomeric (DynaFlex) caulking.

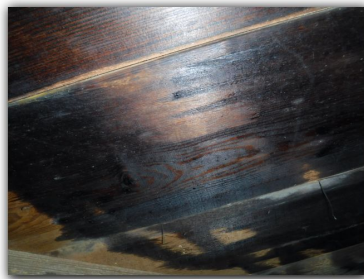
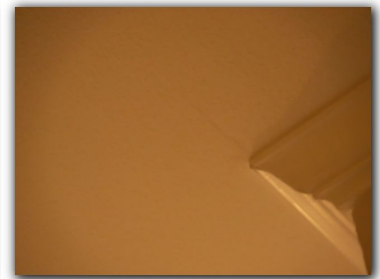
- **Note:** There is evidence of painting and patching to the interior finish and prior interior finish repairs. This condition could limit the Inspectors visual observations and ability to render accurate opinions as to the performance of the structure. Recommend monitoring all signs of previous repair over time.
- Stress cracks observed in one or more locations including back guest bedroom.

- **Notice:** Due to the home being occupied or staged, I was unable to inspect all of the interior surfaces because of personal effects, large, heavy or fragile storage and/or furniture.
- The floors were observed to be out-of-level in some areas of the house, most notably in master bedroom and bathroom area.
- Dis-colored sub-flooring in crawl space observed, which may be caused by floor stain in the past.
- Swelled baseboards observed in kitchen off pantry area. This area was tested with thermal imaging camera and moisture meter but gave no abnormal readings at time of inspection.

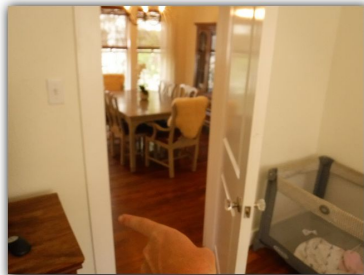
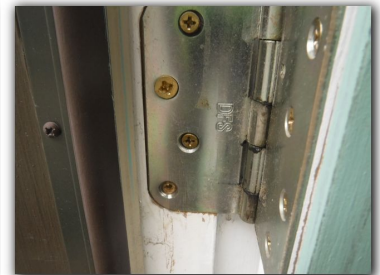
- One or more of the doors in home close on their own without manual assistance and need adjustment or further evaluation. These doors include front guest bedroom.
- One or more of the interior doors do not properly latch closed. Recommend adjustment of strike plate or door as needed. These doors include (but may not be limited to) the guest bedroom closet.
- One or more hinge screws missing at exterior door(s) need installed.

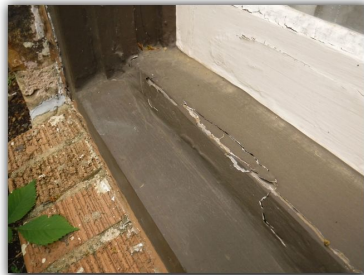
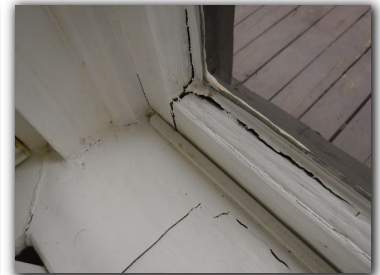
- **Note:** I was unable to inspect the operation of some of the windows due to window treatments, personal effects, large, heavy or fragile storage and/or furniture.
- Re-sealing or painting of one or more exterior sills needed.
- One or more of the interior window sills observed with chipped or missing paint. Recommend re-painting or sealing as needed.
- One or more of the window screens were observed to be missing.
- Some of the windows are painted shut and cannot be opened. This poses fire safety hazard for means of egress.
- Some interior wood framing around windows separated need re-secured or sealed in master bedroom.

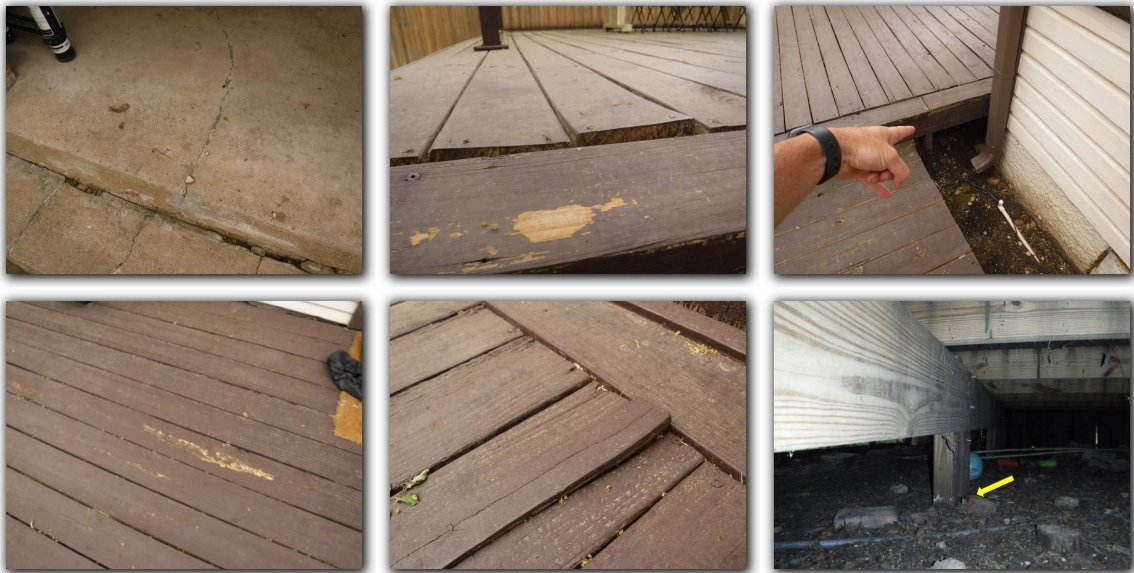
- Minor cracks and/or deficiencies were observed in the front porch area. Recommend monitoring all cracks over time.
- Areas 36" over grade soil off deck should have guardrail for safety.
- One or more un-level areas of deck observed, warped or damaged planks, posing potential trip hazard.
- Re-staining or painting of deck needed.
- Wood to ground contact observed at deck supports poses conducive condition for wood destroying insects.

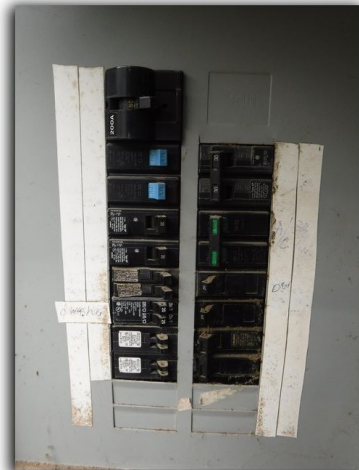
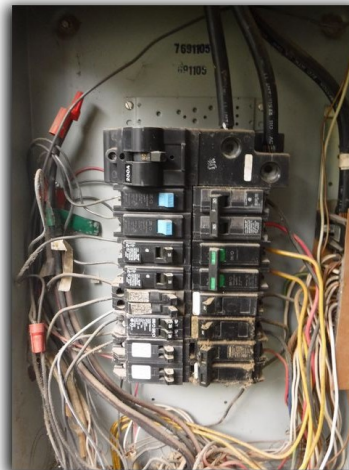
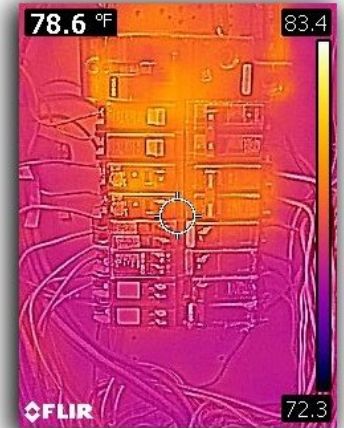
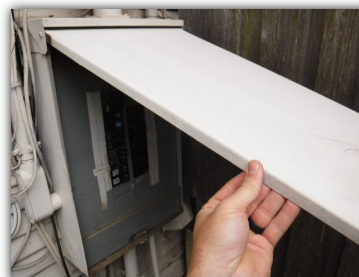
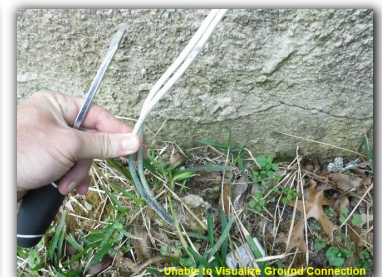
- The breakers (over current devices) in the electrical panel are not properly labeled.
- One or more neutral wires were improperly installed under single terminal(s) at the neutral bus bar. Neutral wires carry electrical current and current building standards do not allow more than one wire per terminal on the neutral bus bar since they may not be as firm as single tapping and can become loose. This condition does not meet today's standards and should be corrected as needed.
- Panel cover will not hold open along exterior wall.

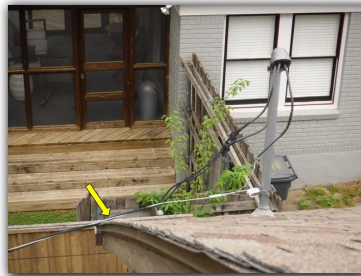
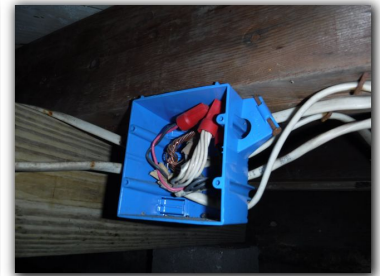
- The ground electrode system connection to the cold water line could not be located. Under current electrical standards the connection should be accessible unless plastic (Pex) water lines are installed throughout the house.
- I was unable to locate a grounding rod (Grounding Electrode) or supplement grounding source for the electrical system (or connection). Under current standards, all grounding connections should be visible above grade or properly labeled to locate. This is a common deficiency where grounding connections may be made below grade soil and out of view.

- Open electrical junction box(es) were observed in the crawl space area. All open junction box(es) in the crawl space should be properly enclosed. Open junction box(es) were located under the master bedroom and hallway area of main home.
- Romex or branch wiring should be elevated and secured along floor joists and off ground in crawl space.

- The service wires were observed to be in contact with the roof structure. This condition does not meet electrical standards and should be corrected as necessary.

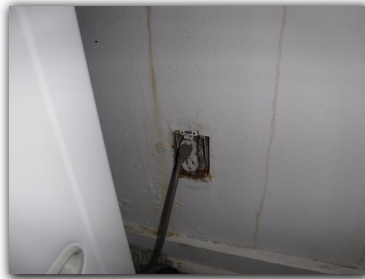
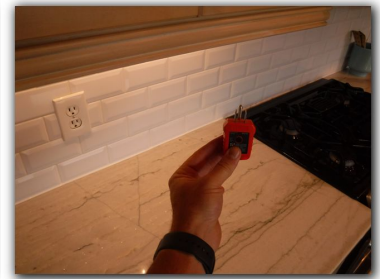
- The exterior receptacles do not appear to be connected to a ground fault circuit interrupter (GFCI) device. Under current electrical standards, all of the exterior receptacles should have GFCI protection.
- Not all of the kitchen counter top receptacles appear to be connected to a ground fault circuit interrupter (GFCI) device. Under current electrical standards, all of the kitchen counter top receptacles should have GFCI protection.
- **Notice:** Current NEC requirements extend to any electrical circuit or appliance within 6 feet of a sink/basin be GFCI (ground fault circuit interrupter) protected.

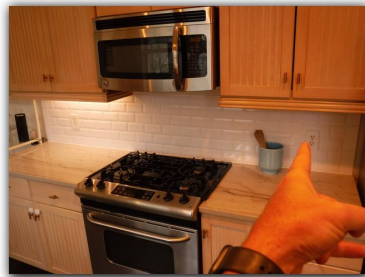
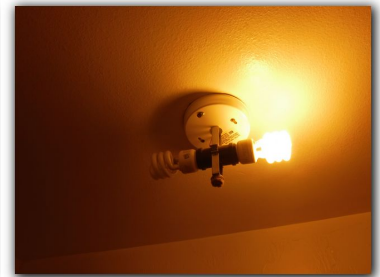
- One or more light bulbs in fixtures were observed to be burned out and in need of replacement or further evaluation as needed. These fixtures include (but are not limited to) the closet light,
- Flickering or intermittent light at kitchen counter top observed to right of range.
- One or more closet lights were observed without covers/diffusers. This does not meet today's current standards.

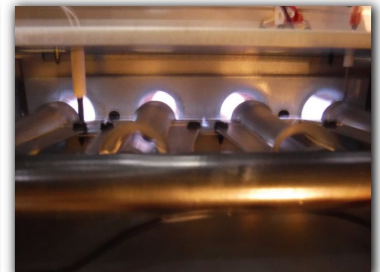
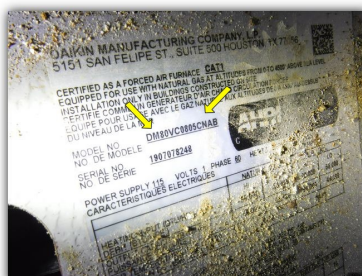
- This component appears to be performing adequately at the time of this inspection. It is achieving an operation, function, or configuration consistent with accepted industry practices for its age.
- The heater gas supply line is not equipped with a sediment trap just before the gas appliance connector. This condition does not meet current installation requirements but may not have been required at time of build.
- Flue strapping is missing to secure between rafter in attic.

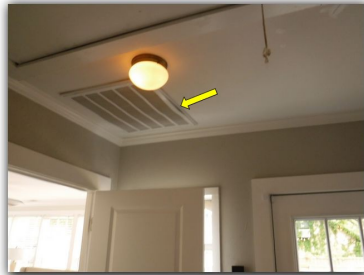
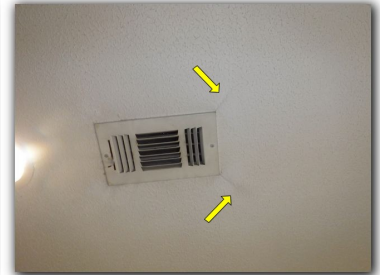
- The duct system was observed to be dirty and needs to be cleaned for air quality purposes.
- The return air register in laundry and exterior door is poorly located. Recommend return be in hallway area of home and away from exterior doors or next to window openings.
- Some areas of duct work insulation need re-secured in attic space.
- **Note:** An air leakage test is not performed and is beyond the scope of a general home inspection, to verify any potential compromises in duct work running through attic or between walls.

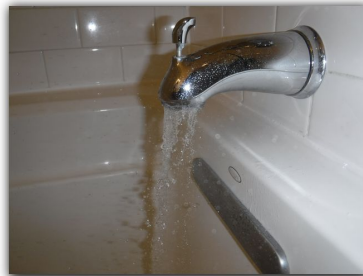
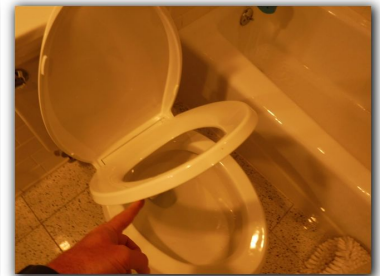
- Chipped or damaged interior sink at guest bathroom observed.
- The guest bathroom toilet seat does not remain up but falls and adjustment is needed.
- The shower diverter is not properly engaging for shower function at time of inspection in master bathroom. Recommend adjustment or corrective measures as needed.
- Leaking of the Pex line below guest bathroom observed in crawl space. Recommend further evaluation and corrective measures as needed by licensed plumber.

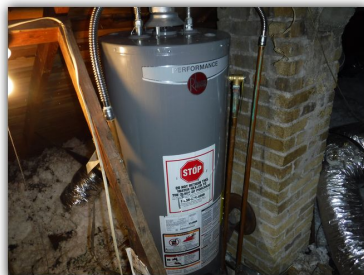
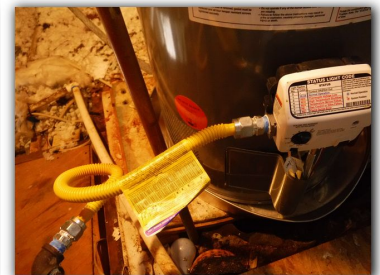
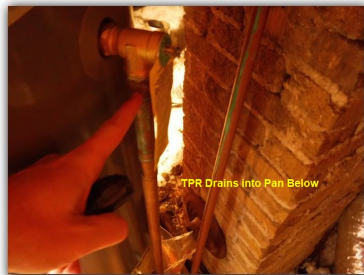
- The temperature and pressure relief discharge pipe is terminating into the water heater drain pan. Under current building standards, this discharge pipe should run downward to the exterior of the structure, turn downward, and terminate within 6-inches of the ground.

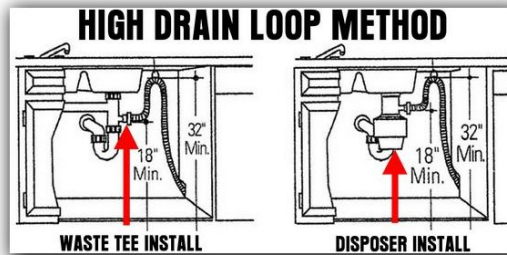
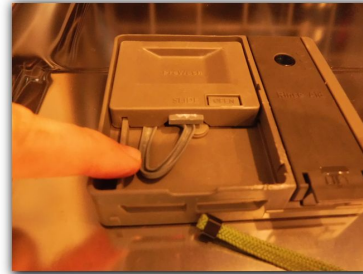
- This component appears to be performing adequately at the time of this inspection.
- The dishwasher drain hose is not properly installed to prevent back flow or anti-siphoning. It is recommended that an air gap device or high drain loop be installed in the drain line.
- Rubber casing loose around soap dish needs repaired.

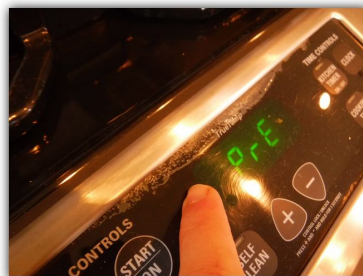
- The temperature of the oven was checked at 350 degrees and rose to 350 degrees, holding that temperature. This meet's today's standard range of 325-375°F.
- The range can be easily tipped over and should be equipped with an anti-tip device, for safety.
- Some delamination of the display for range controls observed.

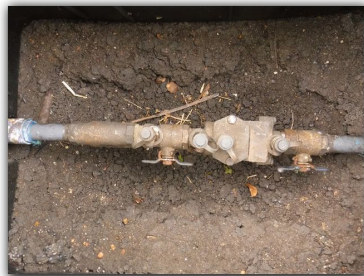
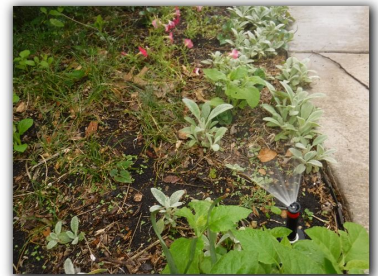
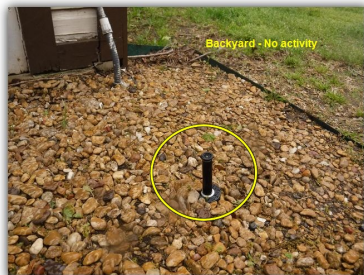
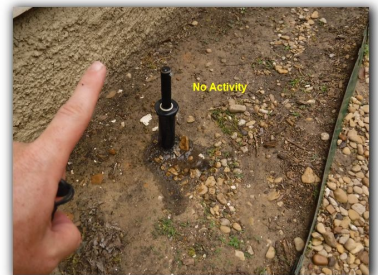
- This component appears to be performing adequately at the time of this inspection. It is achieving an operation, function, or configuration consistent with accepted industry practices for its age.
- Inadequate pressure observed in zone 3 of the system. Recommend further evaluation and correction of this zone or it's related heads as needed.
- There was no activity to sprinkler head in zone 1 along side yard and back yard in zone 5.

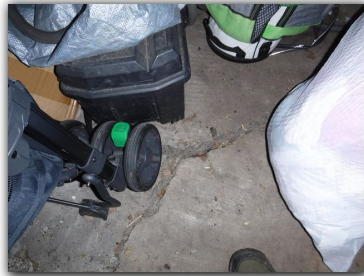
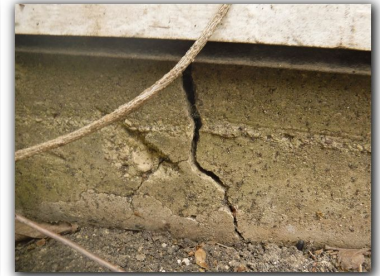
The foundation appears to have had movement that may be beyond normal. A Professional Engineer licensed by the State of Texas or qualified foundation repair company/specialist should be consulted on the current integrity of the foundation and any repairs that may be necessary (if any). The observations made to support the rendering of this opinion are listed but not limited to the following:

- Cracks were observed in the floor of the foundation.
- Floor slopes and/or unlevelness were observed.
- Stress crack(s) were observed in the exterior foundation perimeter beam.

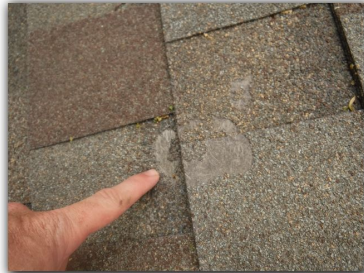
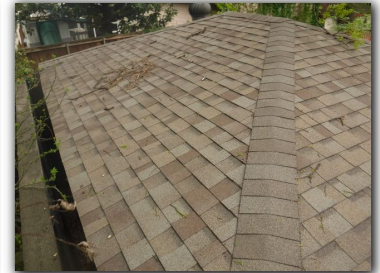
- Some granular loss damage observed to roof shingles, likely due to tree contact.
- Tree and shrub branches need to be trimmed away from the roofing material at all times to help prevent damage to the roofing material. It is the opinion of this Inspector that there are some branches too close to the roofing material at this time and corrective measures are needed.

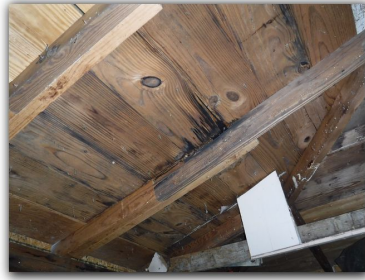
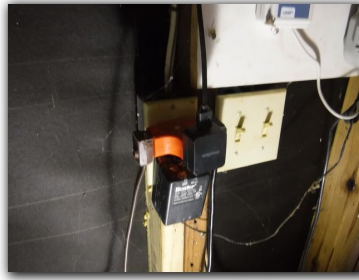
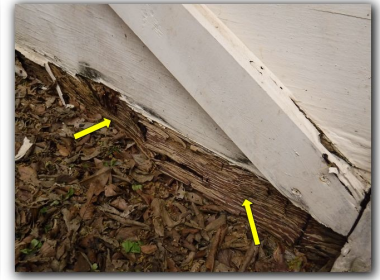
- One or more rafters/joist/other framing members in attic space observed to have water/moisture staining. **Note:** Water staining is common in older homes, but unable to determine if active or not without monitoring area over time.
- One or more of the roof structure rafters were observed to be pulling away from the top ridge board. This condition should be further evaluated and corrected as necessary.
- The garage receptacles do not appear to be connected to a ground fault circuit interrupter (GFCI) device. Under current electrical standards, all of the garage receptacles should have GFCI protection.
- One or more portions of wood type siding members in need of re-painting or re-sealing to protect from elements.
- Wood rot or damaged trim observed off entry door area.
