**Cliff Burton**  
4567 Bass Slap Dr.  
Midlothian, TX 76065

**March 10, 2025**

# PROPERTY INSPECTION REPORT FORM

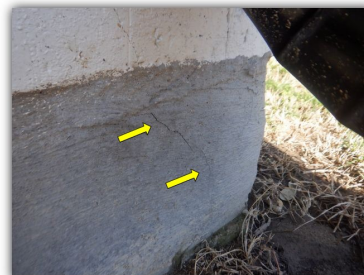
- One or more of the foundation perimeter beam corners were observed to be cracked or sheared off (corner pop/wedge crack). This is a common condition in slab on grade foundations. This condition does not adversely affect the performance of the foundation. However, in some cases, some cosmetic improvements may be necessary.

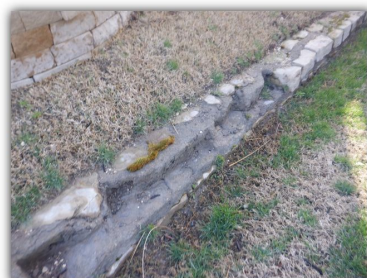
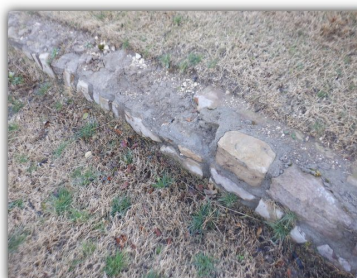
- One or more missing stones at retaining wall need to be replaced or re-secured.

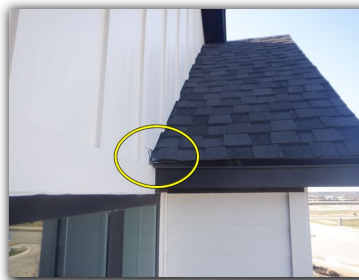
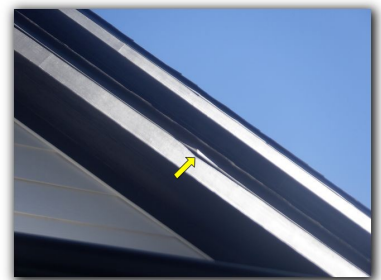
- Some loose drip edge flashing along SW corner of roof.
- There was no kickout flashing details observed at the lower bottom edge of the roof line interface and the sidewall that continues past the edge of the roof. The lack of this kickout flashing may allow water to penetrate at these points.

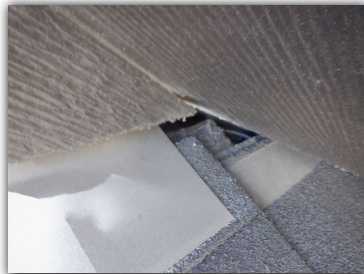
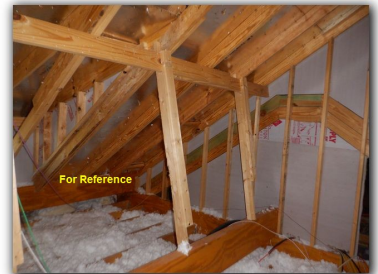
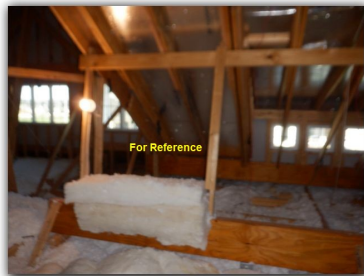
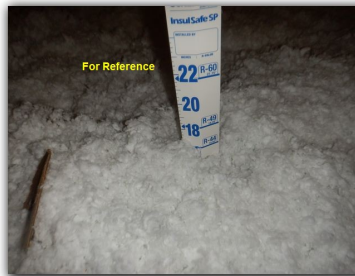
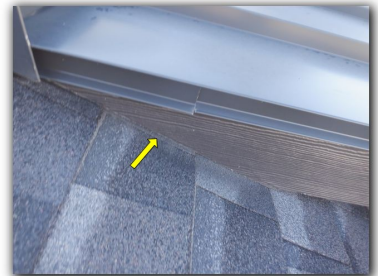
- Opening under eaves observed along south side of structure while walking roof. Recommend correction and sealing area as needed.
- The fascia board ends are in contact with roof covering at time of inspection in one or more locations. This does not meet today's standards requiring at least a 1" separation to prevent water damage or absorption.
- Nail head exposed along upper south side fascia while walking roof.

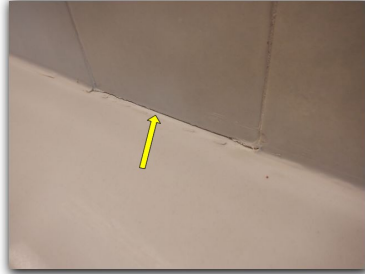
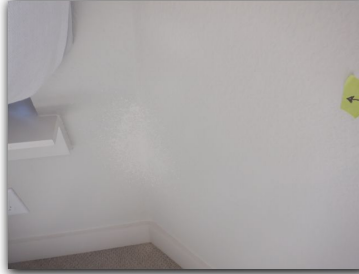
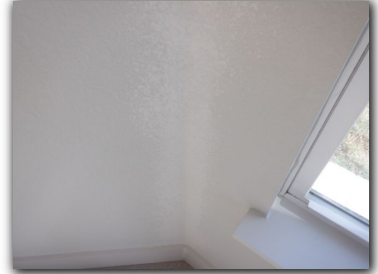
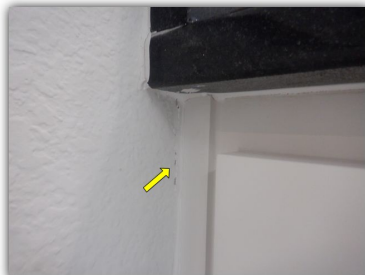
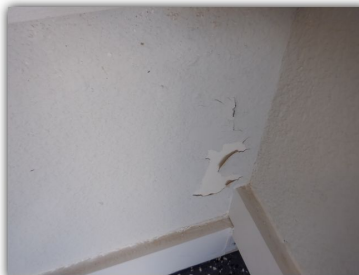
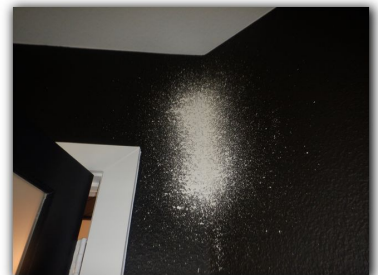
- Areas of un-painted or finished texturing in bedrooms and office observed at time of inspection.
- Re-sealing areas of backsplash tile in kitchen needed.
- Re-sealing below right side master bathroom sink at cabinets.
- Loose texture in garage needs repaired.

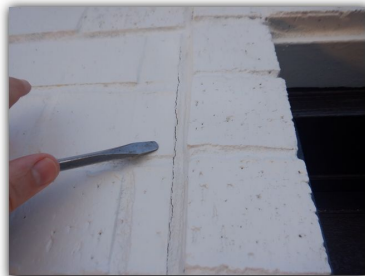
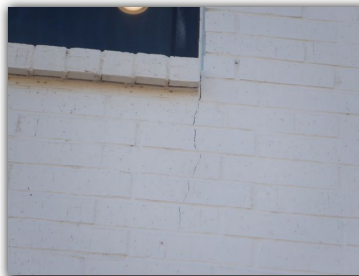
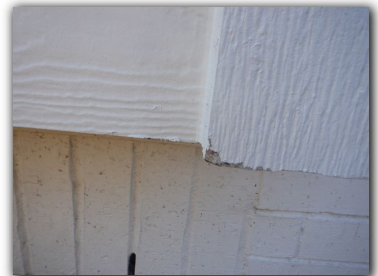
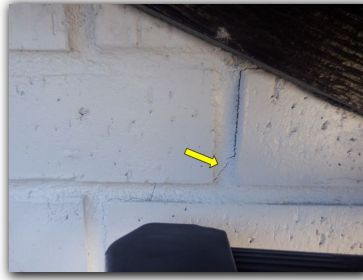
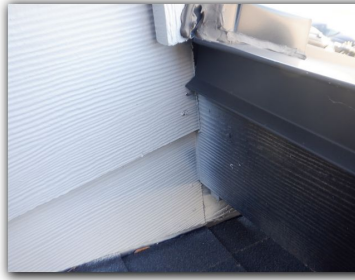
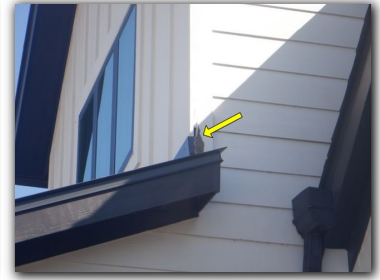
- **Note:** The exterior masonry veneer has been painted. This condition could limit the Inspectors visual observations and ability to render accurate opinions as to the performance of the structure.
- Mortar cracks observed at one or more locations, including upper area of garage (viewed while walking roof). Recommend monitoring all cracks over time or repairing (re-pointing) by qualified mason as needed.
- Deflection cracks were observed in the exterior veneer on the north side of the structure under window opening. Recommend monitoring all cracks over time or repairing as needed (re-pointing by qualified mason).
- Re-painting lower trim needed along SW corner of home at roof.
- Overspray observed along upper trim (fascia) over garage and front entry observed.
- Some minor damage to siding or trim outside kitchen nook windows along north wall observed.

- Mortar cracks observed at one or more locations, including upper area of garage (viewed while walking roof). Recommend monitoring all cracks over time or repairing (re-pointing) by qualified mason as needed.
- Deflection cracks were observed in the exterior veneer on the north side of the structure under window opening. Recommend monitoring all cracks over time or repairing as needed (re-pointing by qualified mason).
- Re-painting lower trim needed along SW corner of home at roof.
- Overspray observed along upper trim (fascia) over garage and front entry observed.
- Some minor damage to siding or trim outside kitchen nook windows along north wall observed.

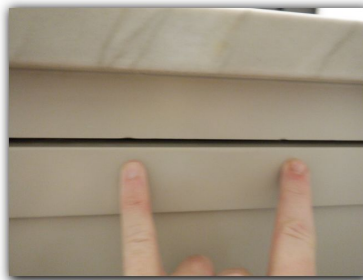
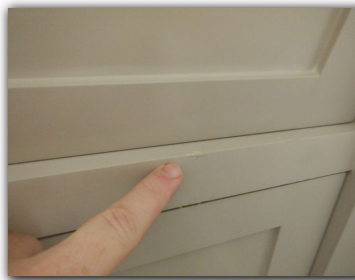
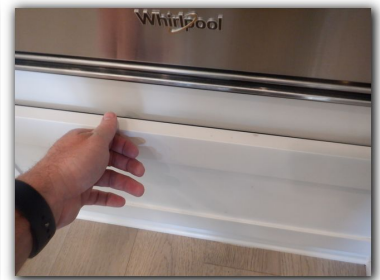
- Damaged lower cabinet door in powder bathroom needs repaired.
- Lower drawer in kitchen below oven does not close properly and adjustment or correction is needed.
- Cook top area drawer in cabinets needs adjustment.

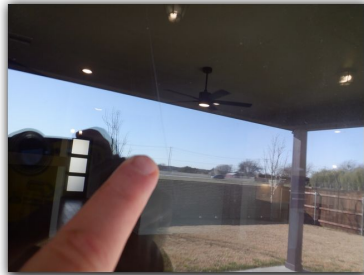
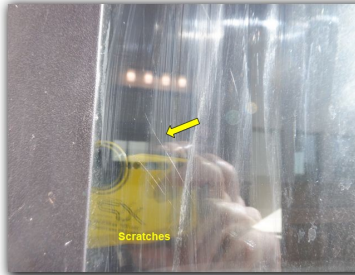
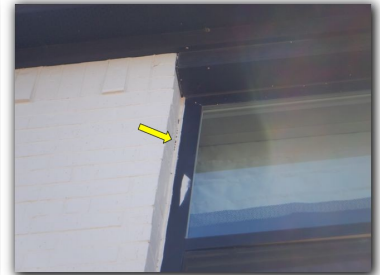
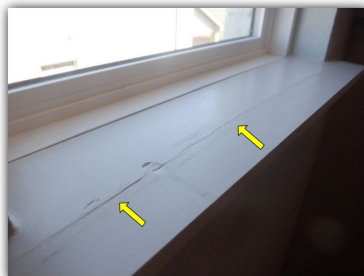
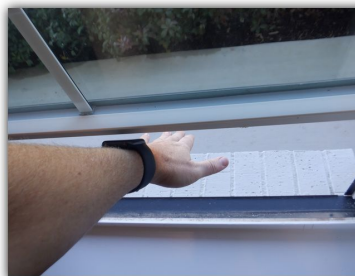
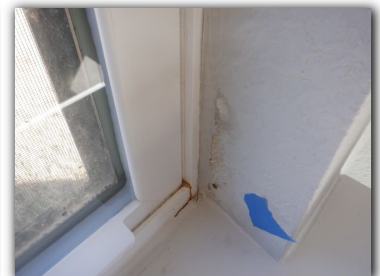
- **Note:** All accessible windows were inspected. Defective thermal paned (double paned) windows are not always visible. Dirt, haze, cloudy/rainy days or solar screens can obscure their condition on the day of inspection. Windows are noted as observed on the day of inspection without any implied warranty.
- Cracked or deteriorated caulking on portions of one or more interior & exterior windows observed in home. Recommend re-sealing and maintaining as needed.
- One or more of the window screens were observed to be missing.
- Surface scratches to one or more exterior sides of windows, including living room and master bathroom (marked with blue tape for reference). Total = 2
- Split or cracked sill at upstairs stairway window needs replaced (attempted to re-paint).

- Cracked or deteriorated caulking on portions of one or more interior & exterior windows observed in home. Recommend re-sealing and maintaining as needed.
- One or more of the window screens were observed to be missing.
- Surface scratches to one or more exterior sides of windows, including living room and master bathroom (marked with blue tape for reference). Total = 2
- Split or cracked sill at upstairs stairway window needs replaced (attempted to re-paint).

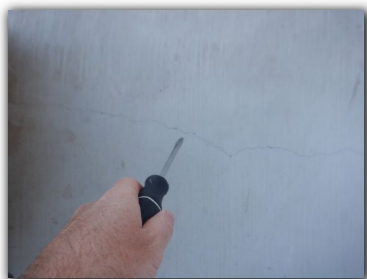
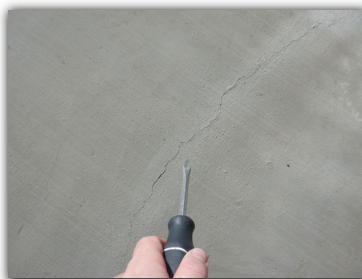
- Minor cracks and/or deficiencies were observed in the porch areas and/or garage. Recommend monitoring all cracks over time.

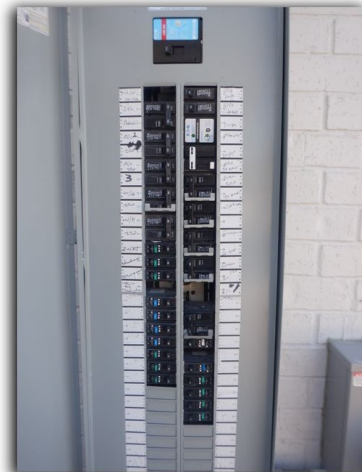
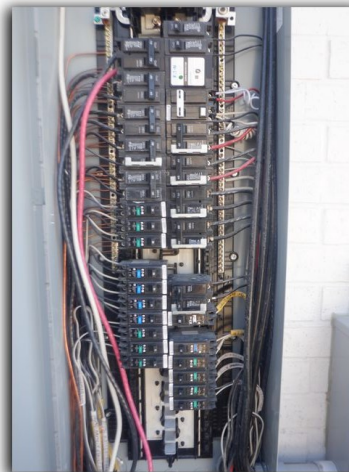
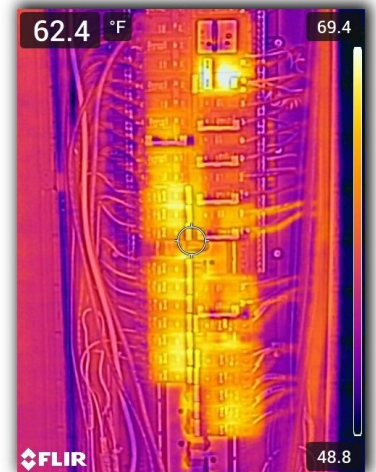
- All blank spaces in the electrical cabinet cover plate (dead front) and /or cabinet need to have fillers.
- Open wires in panel should be removed, capped, or installed to breakers.
- The electrical cabinet cover plate (dead front) should be installed with blunt tip screws and not sharp wood type screws for reasons of safety.

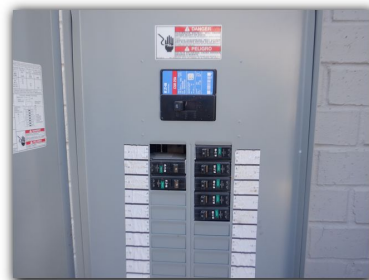
- The cover screw appears stripped and unable to loosen to removed cover.
- The breakers (overcurrent devices) in the electrical panel are not properly labeled.
- One or more of the cabinet cover plate screws are missing and need to be replaced.

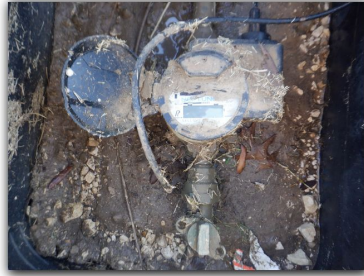
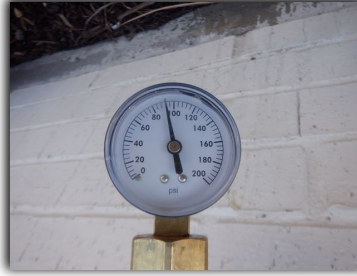
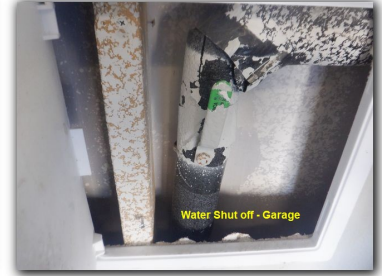
- The water pressure was observed to be above 80 psi at the time of this inspection. Under current plumbing standards the maximum water pressure should be 80 psi. This condition should be further evaluated and corrected as necessary.

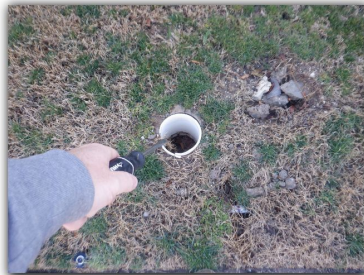
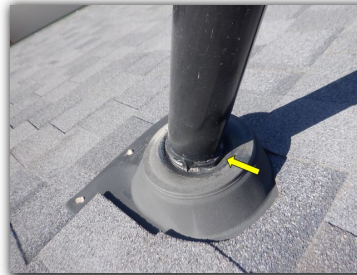
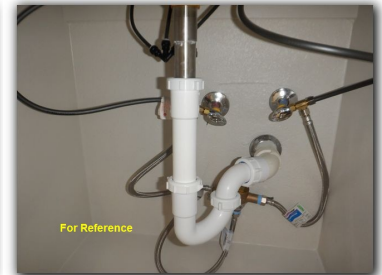
- Vents were observed by: Walked on Roof
- One or more of the neoprene boots at pitched areas of roof need adjustment to prevent holding or pooling water at high side of vent stack penetrations.
- Drain pipe in front yard needs cut/removed, posing trip hazard.

- One or more of the neoprene boots at pitched areas of roof need adjustment to prevent holding or pooling water at high side of vent stack penetrations.
- Drain pipe in front yard needs cut/removed, posing trip hazard.

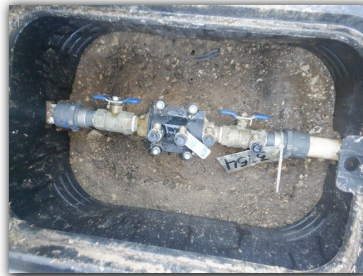
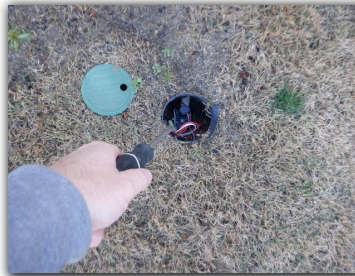
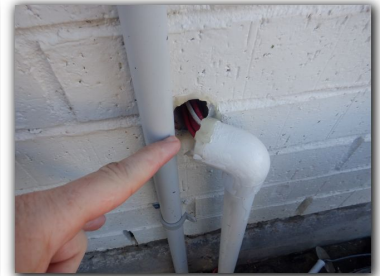
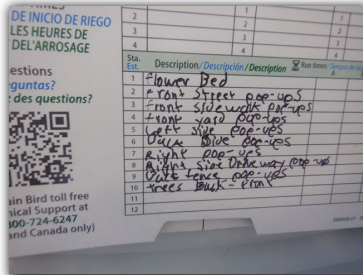
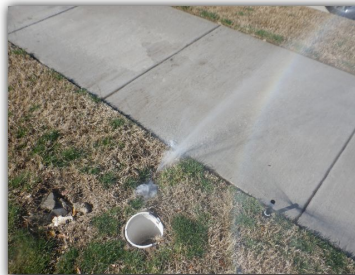
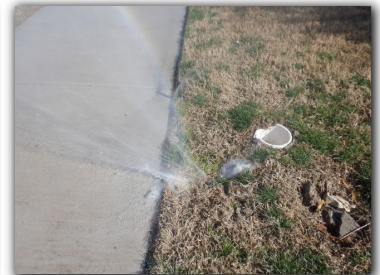
- This component appears to be performing adequately at the time of this inspection. It is achieving an operation, function, or configuration consistent with accepted industry practices for its age.
- Missing valve covers in yard need installed, posing trip hazards.
- Loose and unsecured conduit for irrigation wiring along north wall observed.
- Damaged sprinkler in front yard has been punctured and needs replaced/repaired.
