PROPERTY INSPECTION REPORT FORM

George Castanza <i>Name of Client</i>	04/28/2025 <i>Date of Inspection</i>
1585 Shrinkage Ave., Haslet, TX 76052 <i>Address of Inspected Property</i>	
Ryan Cantrell <i>Name of Inspector</i>	21398 <i>TREC License #</i>
<i>Name of Sponsor (if applicable)</i>	<i>TREC License #</i>

This report is for a pre-sheet rock/drywall construction (phase) inspection. Not all components promulgated by this form may be present and the inspector has made every attempt to report on the current state of the home in it's building progress on this date.

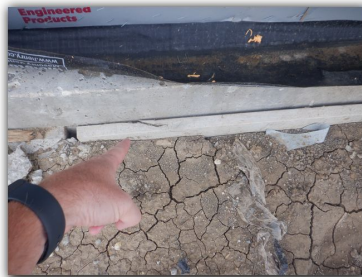
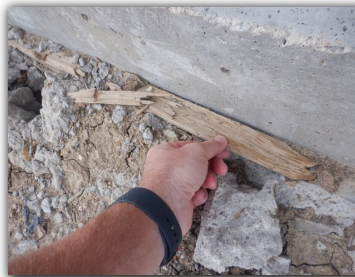
- All form boards left in place along west and north sides of home need removed.
- Exposed post-tension cable end along south wall needs cut and sealed.

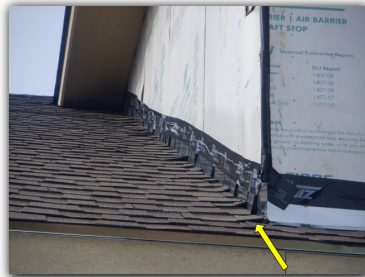
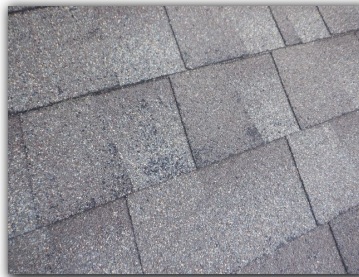
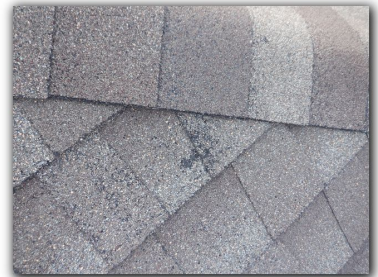
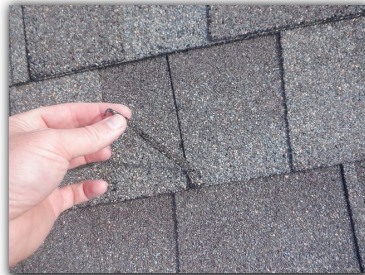
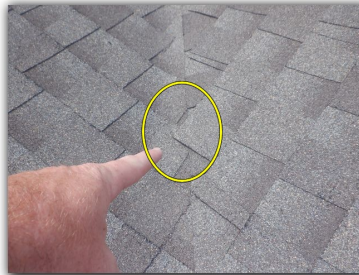
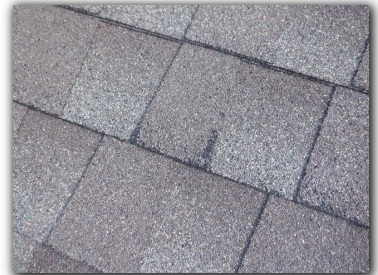
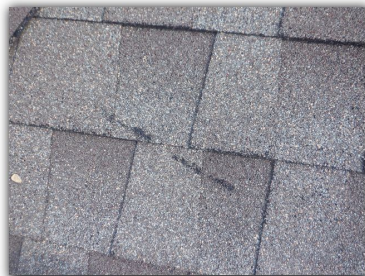
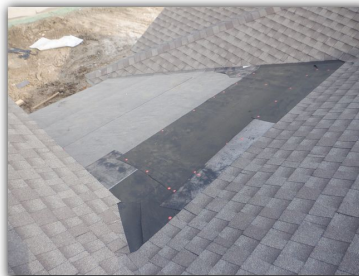
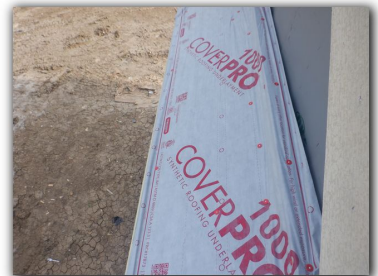
- Portions of roof observed to be bruised/worn due to excessive foot traffic during installation.
- Corner of valley shingle along southeast side of roof not cut.
- Missing metal (assumed) roof covering at time of inspection along front of home.
- Shingles not laying flat or flush to decking along sidewall areas.

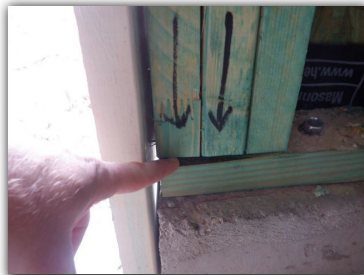
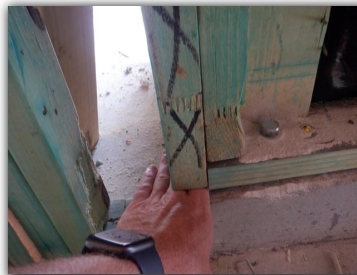
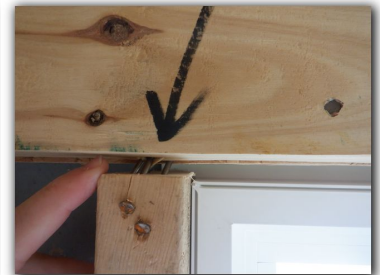
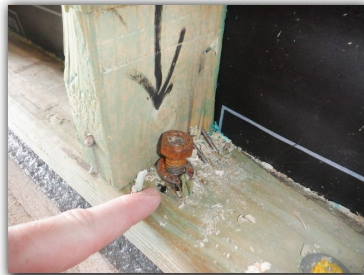
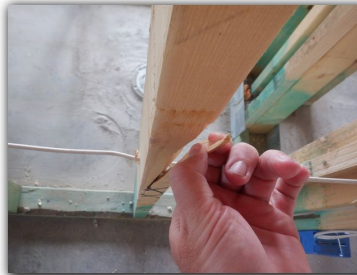
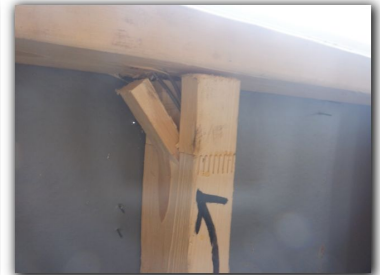
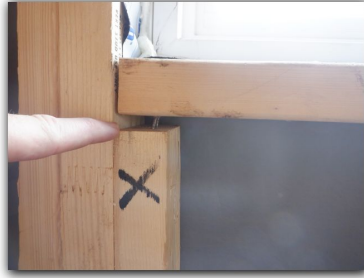
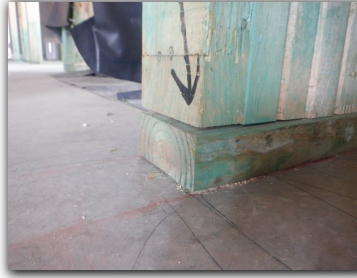
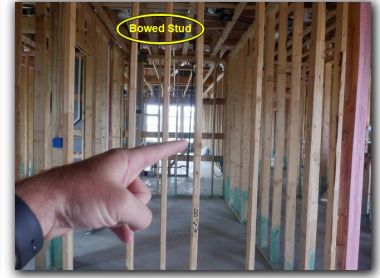
- Bowed stud members observed in single car garage area.
- Support studs off single car garage are not in contact with lower sill plate - and south side of opening, without sill support below. Recommend further evaluation and correction as needed.
- Lower supports below master bathroom window opening is not properly installed, large gaps between top of studs and sill plate observed.
- One or more studs cut short in need of shimming or re-cutting at doorways, observed in
- Split stud needs replaced in pantry (adjacent to master commode closet.
- Loose or un-secured nut to anchor bolt observed in garage along north wall.
- Damaged or split lower cripple studs below window openings observed in master bathroom and living room (south wall).

- Bowed stud members observed in single car garage area.
- Support studs off single car garage are not in contact with lower sill plate - and south side of opening, without sill support below. Recommend further evaluation and correction as needed.
- Lower supports below master bathroom window opening is not properly installed, large gaps between top of studs and sill plate observed.
- One or more studs cut short in need of shimming or re-cutting at doorways, observed in
- Split stud needs replaced in pantry (adjacent to master commode closet).
- Loose or un-secured nut to anchor bolt observed in garage along north wall.
- Damaged or split lower cripple studs below window openings observed in master bathroom and living room (south wall).

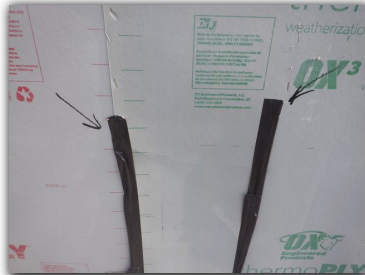
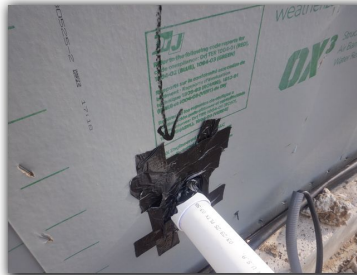
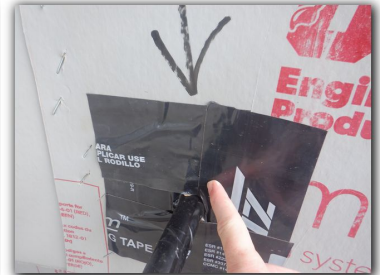
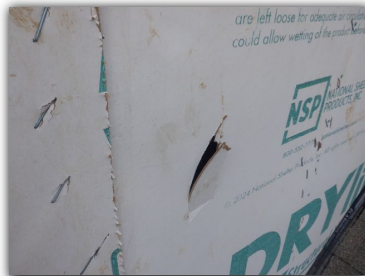
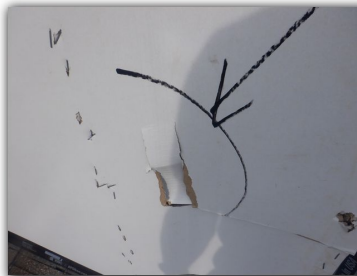
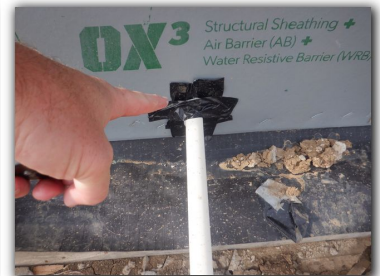
- Multiple areas of wall penetrations along south wall not properly sealed/taped (duct tape and Zip System tape (as observed around all other wall penetrations)).
- One or more damaged areas of house wrap need sealed.
- Improper sealant (duct tape) used along south wall outside of SW bedroom observed at house wrap.
- Improper installation of Zip System tape over back porch gas line.
- Areas of daylight observed inside home through house wrap need sealed.

- Multiple areas of wall penetrations along south wall not properly sealed/taped (duct tape and Zip System tape (as observed around all other wall penetrations).
- One or more damaged areas of house wrap need sealed.
- Improper sealant (duct tape) used along south wall outside of SW bedroom observed at house wrap.
- Improper installation of Zip System tape over back porch gas line.
- Areas of daylight observed inside home through house wrap need sealed.

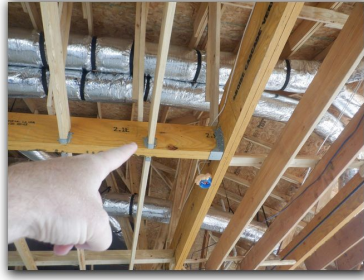
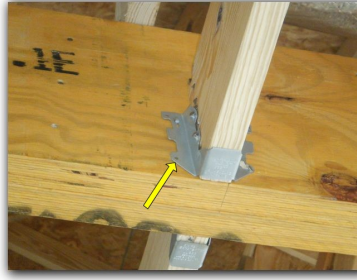
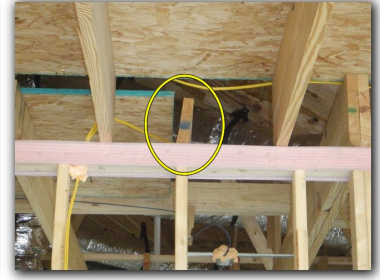
- Ensure all fastener openings at joist hangers have nails installed, missing in living room,
- Ceiling joist visibly tilted or leaning over front middle bedroom. Recommend blocking between ceiling joists to vertically align.

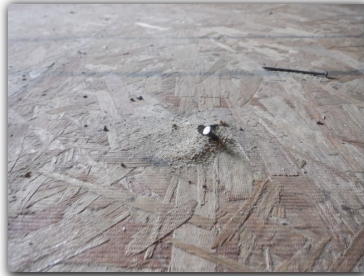
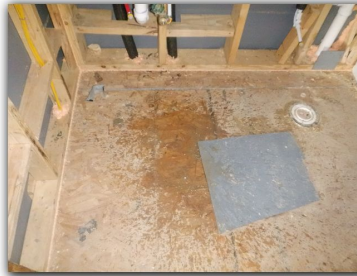
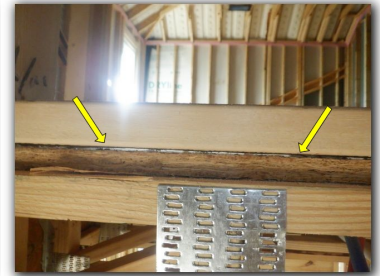
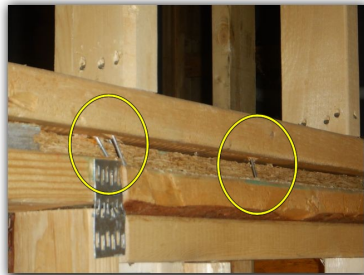
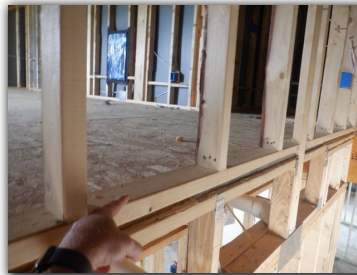
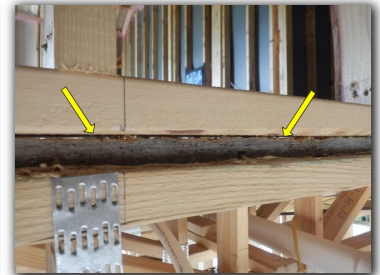
- Minor concrete divots in slab need filled before final flooring is installed.
- Nails not driven into upstairs sub-flooring pose trip hazard.
- Gap observed between upstairs railing lower sill plate and sub-flooring. Recommend correction as needed.
- **Note:** Moisture on sub-flooring upstairs observed at time of inspection.

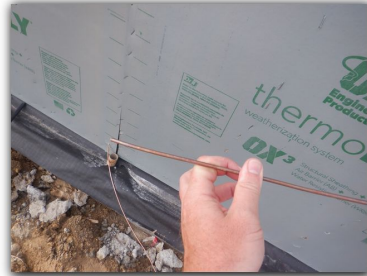
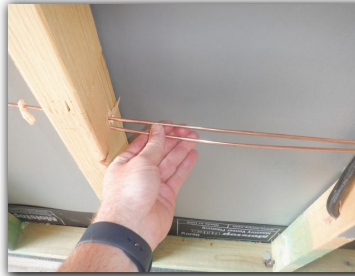
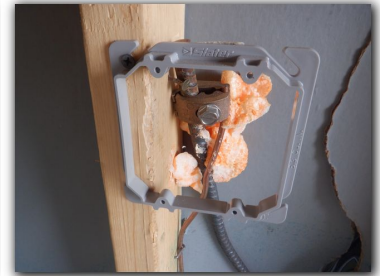
- The ground wires are not connected back to panel at time of inspections, ground ufer located along west wall while panel is located opposite garage along north wall.

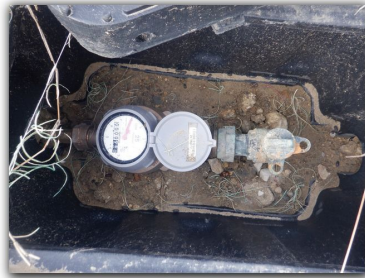
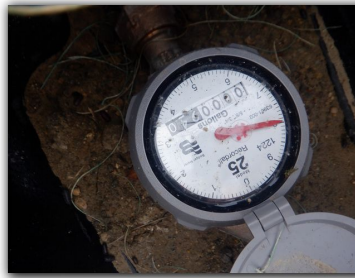
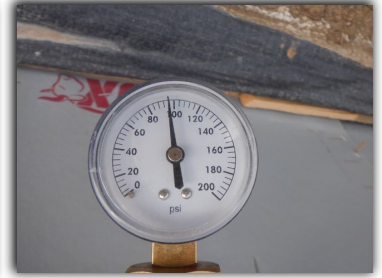
- The water pressure was observed to be above 80 psi at the time of this inspection. Under current plumbing standards the maximum water pressure should be 80 psi. This condition should be further evaluated and corrected as necessary. (this may decrease as homes in area become occupied)
- Note:** There is no visible water shut off in garage or laundry area at time of inspection. Recommend inquiring from builder as to future location of any water shut offs.

- The water pressure was observed to be above 80 psi at the time of this inspection. Under current plumbing standards the maximum water pressure should be 80 psi. This condition should be further evaluated and corrected as necessary. (this may decrease as homes in area become occupied)

- **Note:** There is no visible water shut off in garage or laundry area at time of inspection. Recommend inquiring from builder as to future location of any water shut offs.

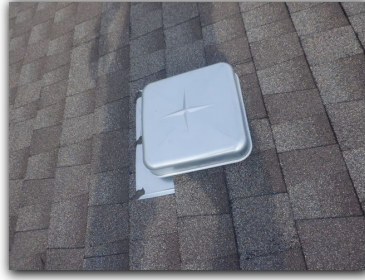
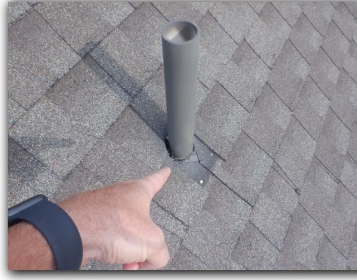
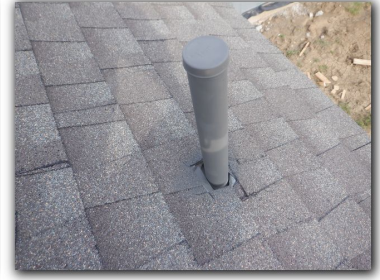
- Vents were observed by: Walked on Roof
- Missing vent boot over master bathroom and north slope needs installed to prevent water intrusion into attic and home.
- Exterior grade paint needed at low profile vents.
- Remove caps on vent stack pipes over master bathroom and SE corner of roof.

- Missing vent boot over master bathroom and north slope needs installed to prevent water intrusion into attic and home.
- Exterior grade paint needed at low profile vents.
- Remove caps on vent stack pipes over master bathroom and SE corner of roof.
