**Lincoln Hawk**  
407 Trucker St.  
Richardson, TX 75081

**April 21, 2025**

# PROPERTY INSPECTION REPORT FORM

Lincoln Hawk <i>Name of Client</i>	04/21/2025 <i>Date of Inspection</i>
407 Trucker St., Richardson, TX 75081 <i>Address of Inspected Property</i>	
Ryan Cantrell <i>Name of Inspector</i>	21398 <i>TREC License #</i>
 <i>Name of Sponsor (if applicable)</i>	 <i>TREC License #</i>

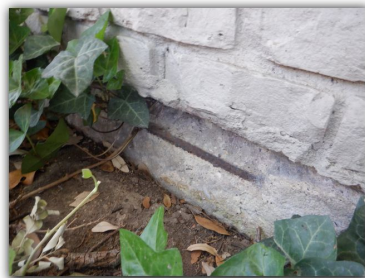
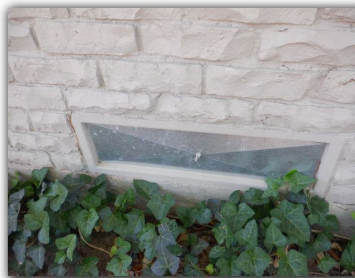
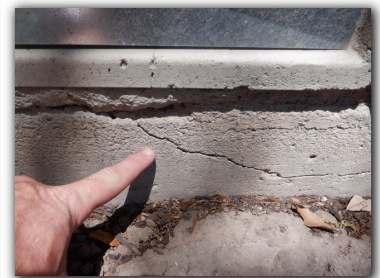
- **Note:** remove vent covers around home.
- The foundation rebar is visible at the edge of the foundation beam and needs to be properly covered on the north side of the structure.
- Stress crack(s) were observed in the exterior foundation perimeter beam. Recommend monitoring all cracks over time.

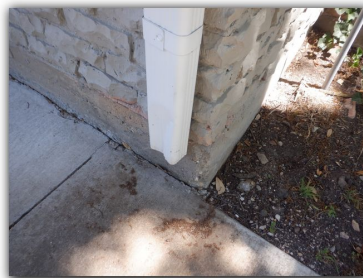
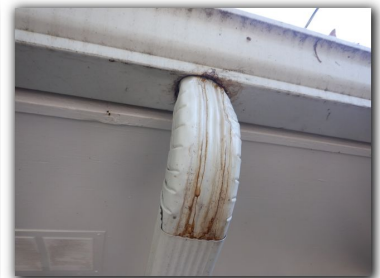
- The gutter downspouts should discharge water at least thirty-six inches (36") away from the foundation perimeter beam. Storm water should be encouraged to flow away from the structure at the points of discharge.
- Minor leaks in the gutter joints and seams should be repaired.
- The gutters require cleaning in one or more areas.
- Kick out missing at lower end of downspout needs installed along west side of home.

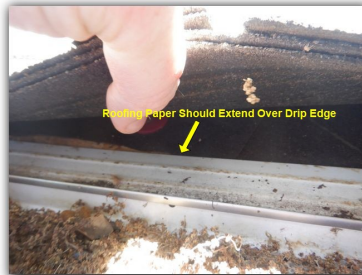
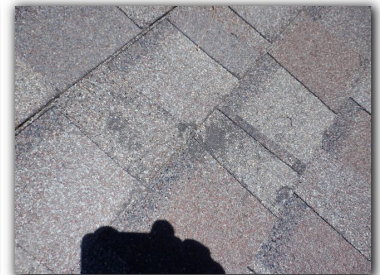
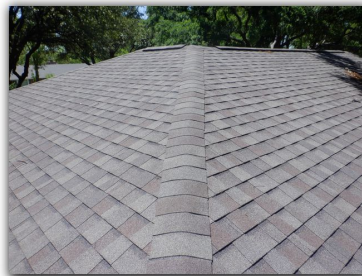
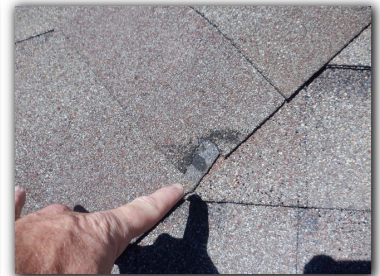
- Damaged shingles observed due to overhanging tree limbs or branches in contact with roof covering. Recommend keeping all vegetation or tree limbs/branches cut back.
- The felt paper was observed to be installed under the lower metal drip edge flashing detail. The manufacturer installation requires the felt paper to be installed over the top of the metal drip edge flashing, in shingle like fashion, to help prevent water intrusion and/or damage to occur behind the fascia board and soffit/eave areas.
- **Note:** All debris, such as leaf's and branches, should be removed from the roof structure.

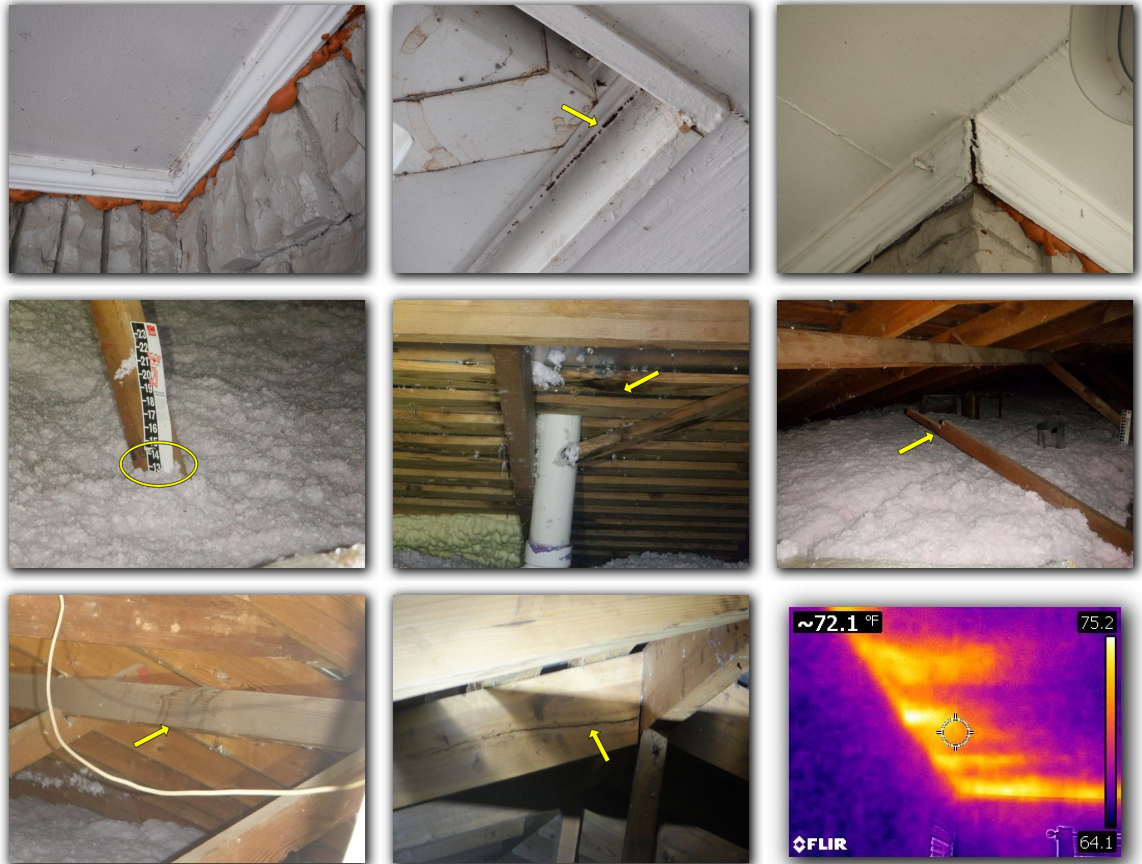
- One or more rafters/joist/other framing members in attic space observed to have water/moisture staining. **Note:** Water staining is common in older homes, but unable to determine if active or not without monitoring area over time.
- Loose purlin support in attic needs re-secured.
- Cracked rafter in attic observed over hallway area.
- Frieze board separation(s) were observed along one or more corners. Recommend re-securing and sealing at corners as needed.
- Spray foam observed sealing frieze boards and brick siding, temporary material.
- One or more areas of fascia and frieze board separations need re-sealed along front of home.
- Areas of missing blown in insulation over SE corner guest bedroom observed, along east and south walls.

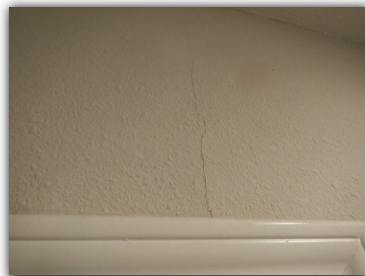
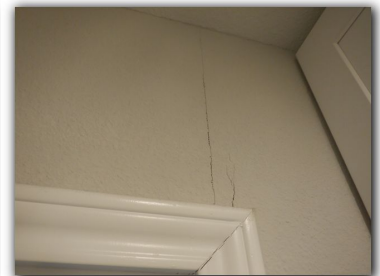
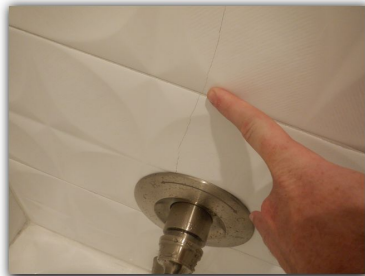
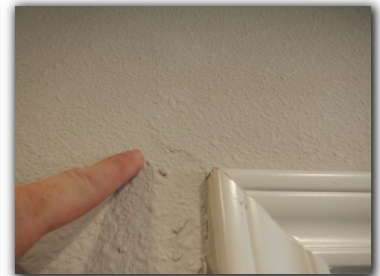
- Cracked tiles in guest shower area over faucet.
- Nail heads were observed to be pushing through the interior finish in one or more locations.
- Stress cracks observed in sheet rock/drywall in one or more areas of home, including (but may not be limited to) bedrooms and bathroom door openings. Recommend monitoring all cracks over time or repairing as needed.

- Interior wall joint cracks (at tape and bed joint of drywall) were observed in one or more bedrooms over doorways. Recommend monitoring all cracks over time or patching/painting as needed.

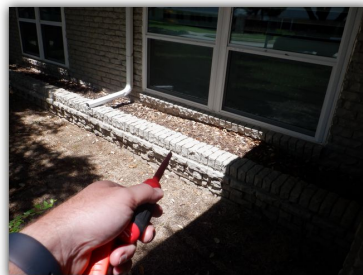
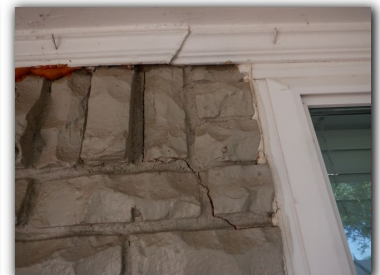
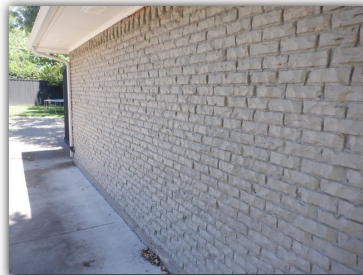
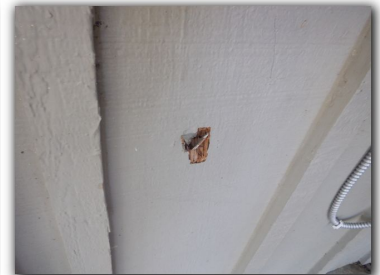
- Mortar cracks observed at one or more locations, including below one or more window openings. Recommend monitoring all cracks over time or repairing (re-pointing) by qualified mason as needed.

- Deflection cracks were observed in the exterior veneer on the west side of the structure. Recommend monitoring all cracks over time or repairing as needed (re-pointing by qualified mason).

- High soil line observed along south wall(s) in planter boxes. This does not meet today's standard requiring 2" to 4" separation between brick veneer and grade level soil.

- Damaged wood siding along north wall around electrical meter.

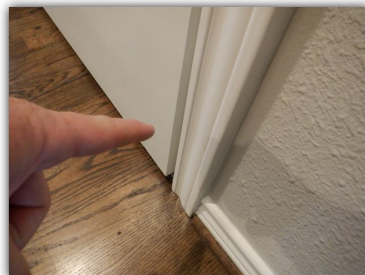
- One or more hinge screws missing at interior doors.
- The back hallway close door does not fit properly within framing.

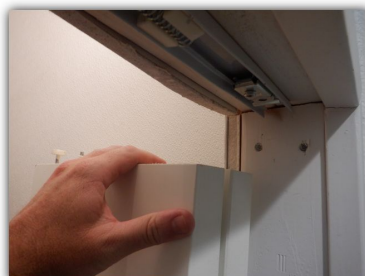
- Sliding glass door off west master bedroom area does not latch/close properly.
- Loose handle to one or more sliding glass doors observed.

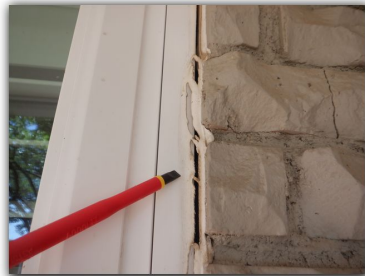
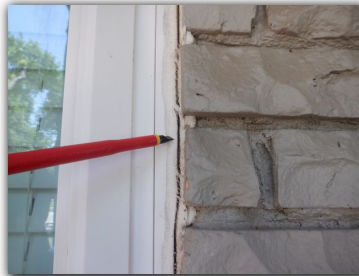
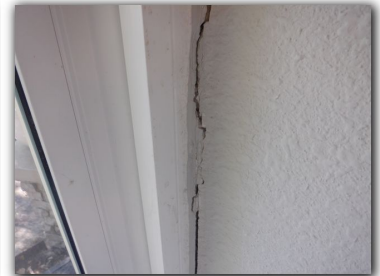
- **Note:** I was unable to inspect the operation of some of the windows due to window treatments, personal effects, large, heavy or fragile storage and/or furniture.
- **Note:** All accessible windows were inspected. Defective thermal paned (double paned) windows are not always visible. Dirt, haze, cloudy/rainy days or solar screens can obscure their condition on the day of inspection. Windows are noted as observed on the day of inspection without any implied warranty.
- Cracked or deteriorated caulking on portions of one or more interior & exterior windows observed in home. Recommend re-sealing and maintaining as needed.

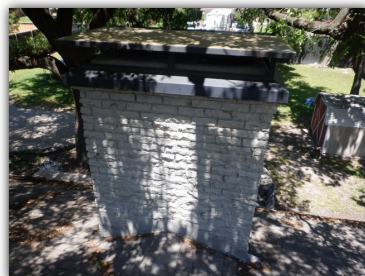
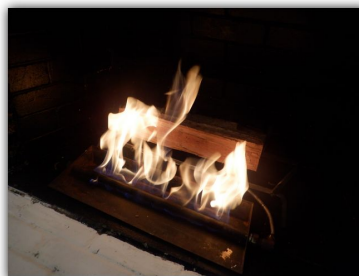
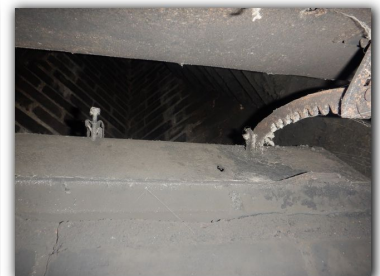
- Viewed chimney from: Walked on Roof
- When artificial gas logs are installed in a firebox with a damper; the damper should be permanently blocked open with a damper clamp (c-clamp) to prevent accidental spillage of carbon monoxide into the living space.
- The chimney flue needs to be cleaned by a Qualified Chimney Sweep. A creosote / soot build-up was observed in the visible flue area.

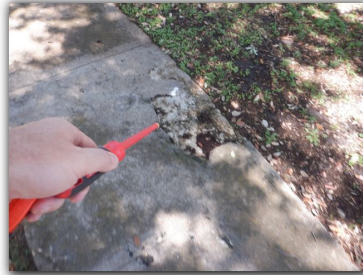
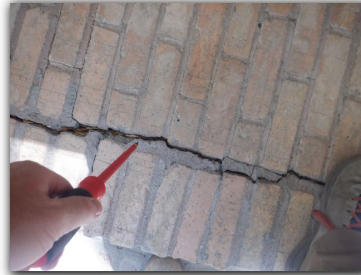
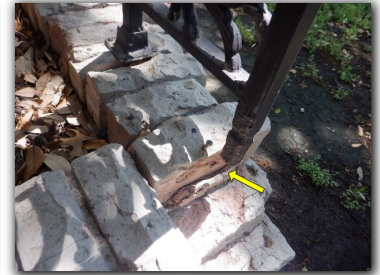
- Minor cracks and/or deficiencies were observed in the driveway and/or garage. Recommend monitoring all cracks over time.
- Front flower bed support missing bricks need repaired.
- Cracked mortar at front entry steps observed.

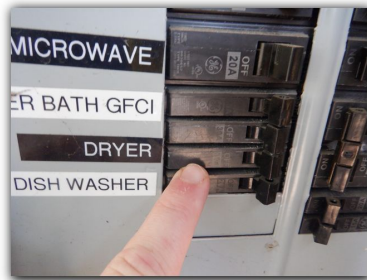
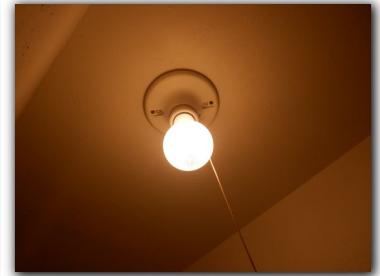
- One or more closet lights were observed without covers/diffusers. This does not meet today's current standards.
- One or more light bulbs in fixtures were observed to be burned out and in need of replacement or further evaluation as needed. These fixtures include (but are not limited to) the bathroom vanity lights.
- Master bedroom ceiling fan is hardwired and no visible switch in area to operate. This configuration does not meet today's electrical standards.
- One or more wobbly ceiling fans need adjustment, correction and balancing.

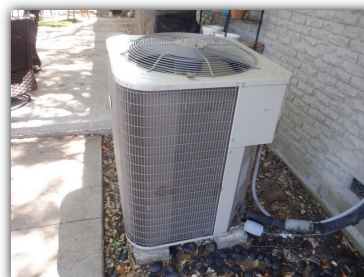
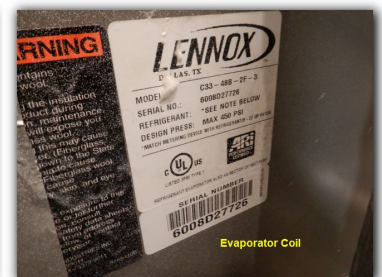
- The system was operating for over 30 minutes and ambient temperature did not drop below beginning temperature of 74°F. Recommend further evaluation by licensed HVAC technician of the system or thermostat as needed.
- Leaking in the past observed around condensate line at unit.

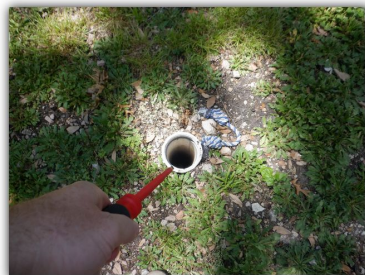
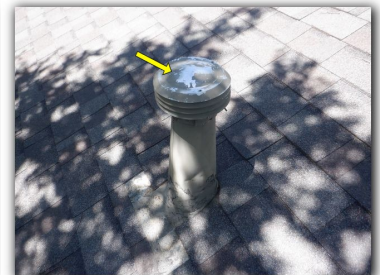
- Vents were observed by: Walked on Roof
- Collar at furnace flue should be adjusted (moved down) at flue connection.
- One or more dent's or ding's observed to gas b-vent termination caps at roof.
- Missing yard clean out in back yard needs installed, posing trip hazard.

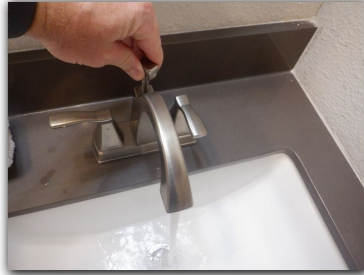
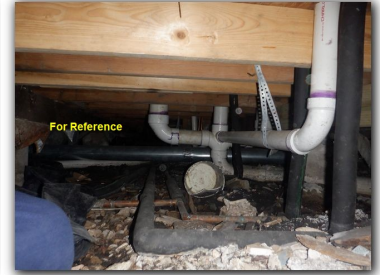
- Missing drain plug to master bathroom sink observed.
- The drain plug at guest bathroom sink/basin did not engage properly to hold water. Recommend adjustment or further evaluation as needed.
- **Note:** One or more lower cabinets observed with previous water staining or damage in bathrooms. While no active or current leaks were detected, recommend monitoring over time.

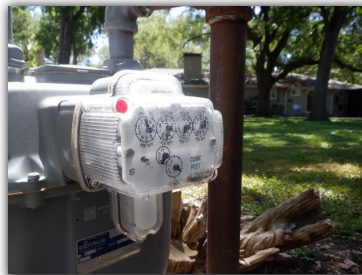
- This component appears to be performing adequately at the time of this inspection.
- There is no bonding clamp at meter, which may not have been required at time of build but no longer meet's today's standards where no visible and present.

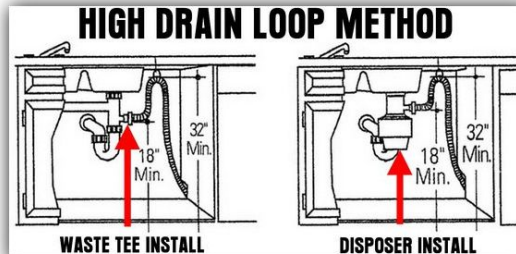
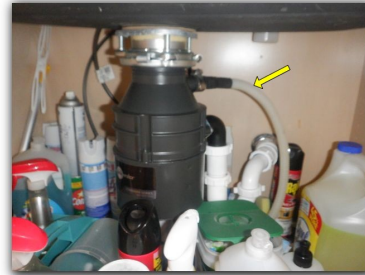
- This component appears to be performing adequately at the time of this inspection.
- The dishwasher drain hose is not properly installed to prevent back flow or anti-siphoning. It is recommended that an air gap device or high drain loop be installed in the drain line.

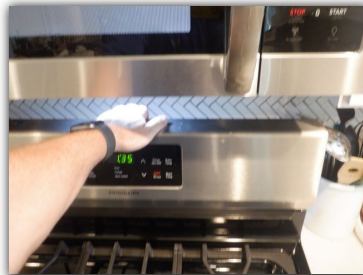
- The temperature of the oven was checked at 350 degrees and rose to 351 degrees, holding that temperature. This meet's today's standard range of 325-375°F.
- The range can be easily tipped over and should be equipped with an anti-tip device, for safety.

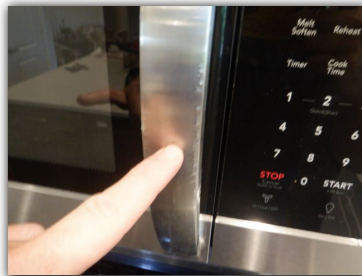
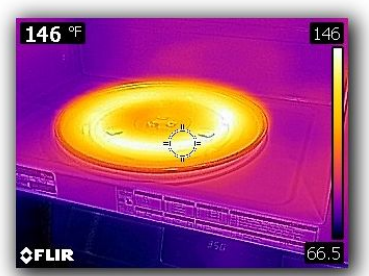
- This component appears to be performing adequately at the time of this inspection.
- Deteriorated coating around microwave door observed.

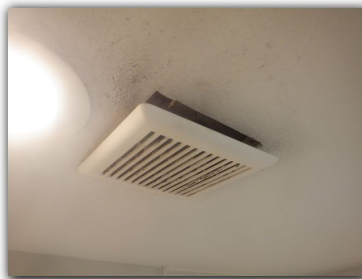
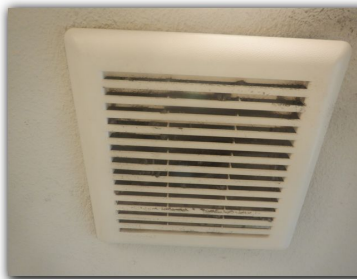
- This component appears to be performing adequately at the time of this inspection.
- Loose mechanical exhaust in guest bathroom needs re-secured at ceiling.
- Cleaning of one or more mechanical exhaust vents in bathrooms needed.

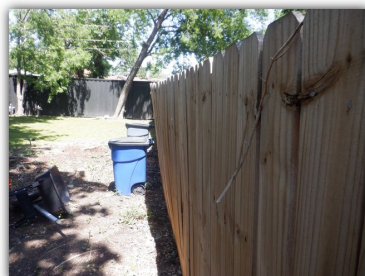
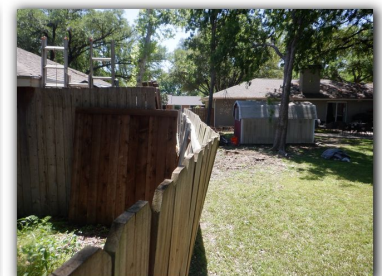
- One or more portions of the east side fence are out of vertical alignment and leaning. Recommend adjustment/repair or further evaluation as needed.
