**Dwight Schrute**  
4321 Dunder Dr.  
Dallas, TX 75223

**April 12, 2022**

# PROPERTY INSPECTION REPORT FORM

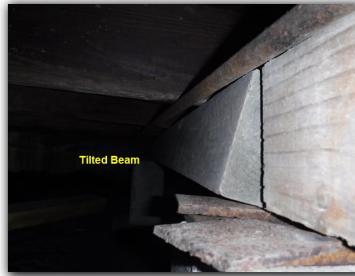
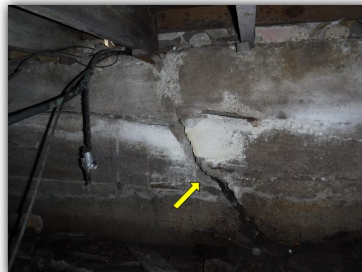
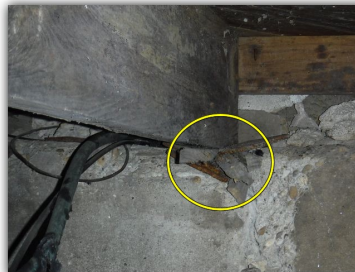
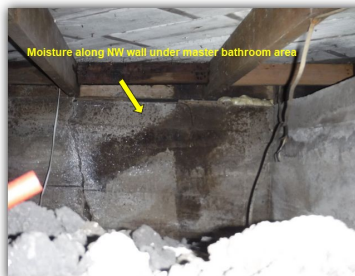
Some of the pier and beam foundation structural components appear to have deficiencies that are beyond normal. The Buyer should have the cause and remedy investigated by a foundation repair company familiar with pier and beam type structures. The observations made to support the rendering of this opinion are listed but may not be limited to the following:

- Leaning and vertically mis-aligned beam under living room area observed.
- One or more piers need shimming to make contact with beam above as gap was observed between pier and beam. Manually able to move piers below beams in one or more locations.
- The beam or floor joists below southeast wall (kitchen and dining area) are not properly supported, shims loose or beams/joists not bearing at least 3" on foundational wall.
- Moisture observed below guest bathroom and into master bathroom (North corner of home) due to leak in Pex line below. Recommend further evaluation or extend of any structural compromises as needed in this area.
- Larger than typical cracks in perimeter beam observed, most notably along SE wall.

- Stress crack(s) were observed in the exterior foundation perimeter beam. Recommend monitoring all cracks over time.
- Inadequate ventilation observed. Recommend improving venting of the crawl space as needed.

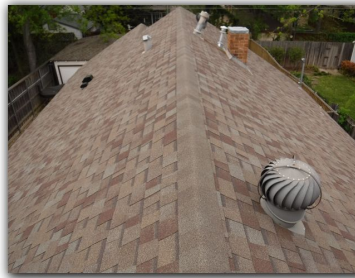
- One or more nail heads were observed to be exposed on roof covering. Recommend all exposed nail heads be sealed and protected from elements to prevent rust/deterioration.

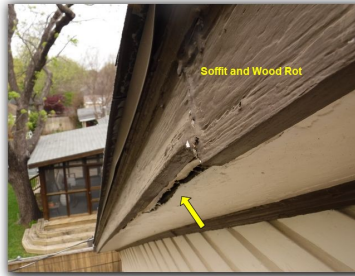
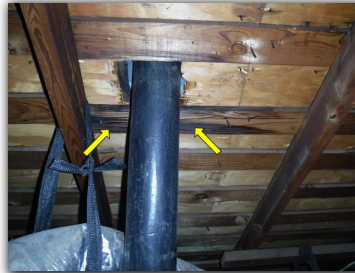
- One or more rafters/joist/other framing members in attic space observed to have water/moisture staining. **Note:** Water staining is common in older homes, but unable to determine if active or not without monitoring area over time.

- Damaged decking member observed in attic space area.
- There appears to be a small scorched area of rafter in attic space, over kitchen/living area. The structural stability of this rafter does not appear to be compromised, however, recommend sistering or repairing rafter as needed.

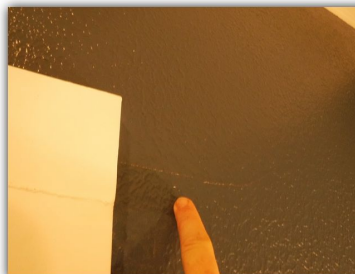
- **Notice:** Due to the home being occupied or staged, I was unable to inspect all of the interior surfaces because of window treatments, personalized wall treatments / finishes, personal effects, large, heavy or fragile storage and/or furniture.
- **Note:** There is evidence of painting and patching to the interior finish and prior interior finish repairs. This condition could limit the Inspectors visual observations and ability to render accurate opinions as to the performance of the structure. Recommend monitoring all signs of previous repair over time.
- Stress cracks observed in sheet rock/drywall in one or more areas of home, including (but may not be limited to) master bathroom entry, opening to dining area, and guest bathroom. Recommend monitoring all cracks over time or repairing as needed.

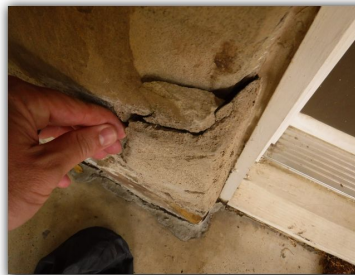
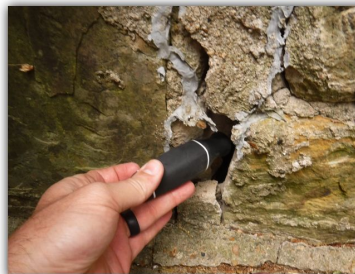
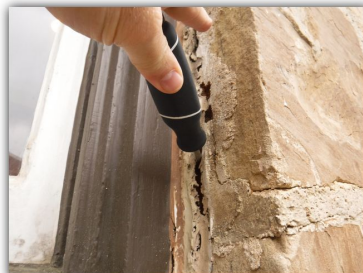
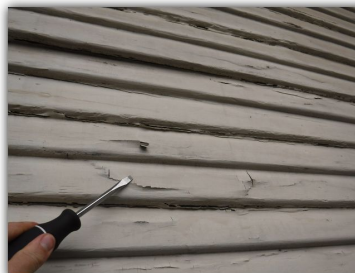
- **Note:** Lead based paint testing is not performed and falls outside the scope of the general home inspection.
- Mortar cracks observed at one or more locations. Recommend monitoring all cracks over time or repairing (re-pointing) by qualified mason as needed.

- One or more mortar gaps observed at brick veneer. Recommend properly sealing off as needed by qualified mason.
- All wall penetrations such as wiring, receptacles, and meter boxes should be sealed where meeting wall.

- One or more portions of wood type siding members in need of re-painting or re-sealing to protect from elements.
- Loose stone off front door/porch observed.

- Caulking improvements are recommended for the area between the exterior veneer and the window frames. It is recommended to use elastomeric (DynaFlex) caulking.

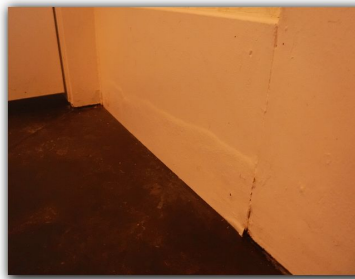
- **Notice:** Due to the home being occupied or staged, I was unable to inspect all of the interior surfaces because of personal effects, large, heavy or fragile storage and/or furniture.
- The floors were observed to be out-of-level in some areas of the house, most notably in master bedroom and bathroom area.
- Dis-colored sub-flooring in crawl space observed, which may be caused by floor stain in the past.
- Swelled baseboards observed in kitchen off pantry area. This area was tested with thermal imaging camera and moisture meter but gave no abnormal readings at time of inspection.

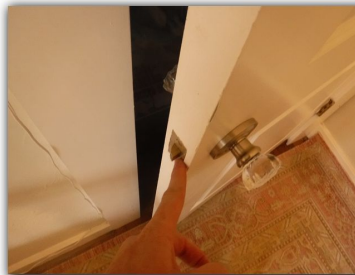
- One or more of the doors in home close on their own without manual assistance and need adjustment or further evaluation. These doors include front guest bedroom.
- One or more of the interior doors do not properly latch closed. Recommend adjustment of strike plate or door as needed. These doors include (but may not be limited to) the guest bedroom closet.
- One or more hinge screws missing at exterior door(s) need installed.

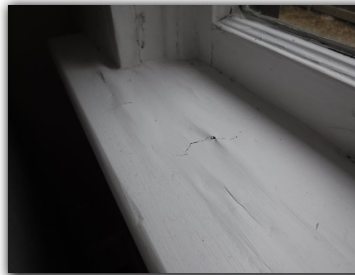
- **Note:** I was unable to inspect the operation of some of the windows due to window treatments, personal effects, large, heavy or fragile storage and/or furniture.
- Re-sealing or painting of one or more exterior sills needed.
- One or more of the interior window sills observed with chipped or missing paint. Recommend re-painting or sealing as needed.
- One or more of the window screens were observed to be missing.
- Some of the windows are painted shut and cannot be opened. This poses fire safety hazard for means of egress.
- Some interior wood framing around windows separated need re-secured or sealed in master bedroom.

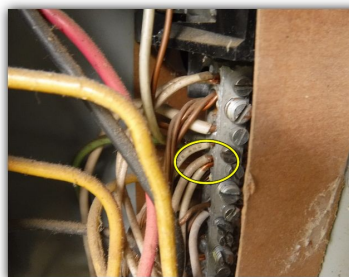
- The breakers (over current devices) in the electrical panel are not properly labeled.
- One or more neutral wires were improperly installed under single terminal(s) at the neutral bus bar. Neutral wires carry electrical current and current building standards do not allow more than one wire per terminal on the neutral bus bar since they may not be as firm as single tapping and can become loose. This condition does not meet today's standards and should be corrected as needed.
- Panel cover will not hold open along exterior wall.

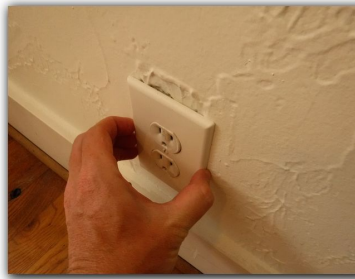
- The exterior receptacles do not appear to be connected to a ground fault circuit interrupter (GFCI) device. Under current electrical standards, all of the exterior receptacles should have GFCI protection.
- Not all of the kitchen counter top receptacles appear to be connected to a ground fault circuit interrupter (GFCI) device. Under current electrical standards, all of the kitchen counter top receptacles should have GFCI protection.
- **Notice:** Current NEC requirements extend to any electrical circuit or appliance within 6 feet of a sink/basin be GFCI (ground fault circuit interrupter) protected.

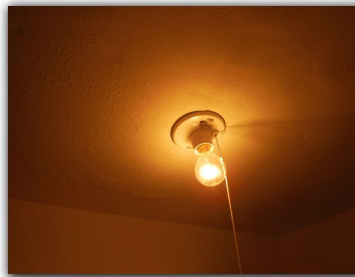
- One or more light bulbs in fixtures were observed to be burned out and in need of replacement or further evaluation as needed. These fixtures include (but are not limited to) the closet light,
- Flickering or intermittent light at kitchen counter top observed to right of range.
- One or more closet lights were observed without covers/diffusers. This does not meet today's current standards.

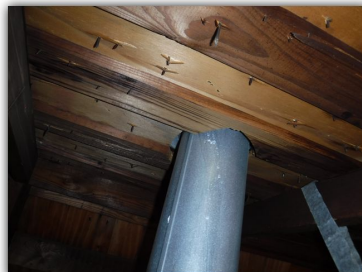
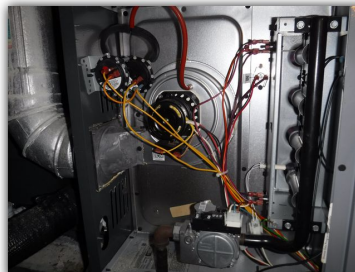
- This component appears to be performing adequately at the time of this inspection. It is achieving an operation, function, or configuration consistent with accepted industry practices for its age.
- The heater gas supply line is not equipped with a sediment trap just before the gas appliance connector. This condition does not meet current installation requirements but may not have been required at time of build.
- Flue strapping is missing to secure between rafter in attic.

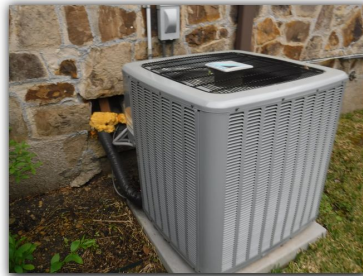
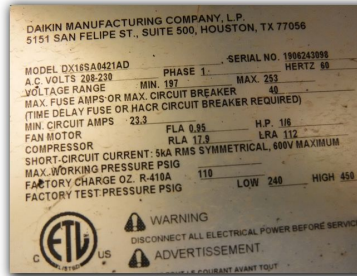
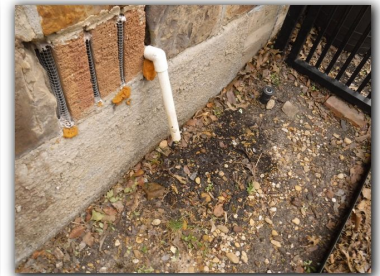
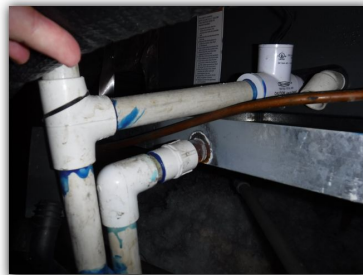
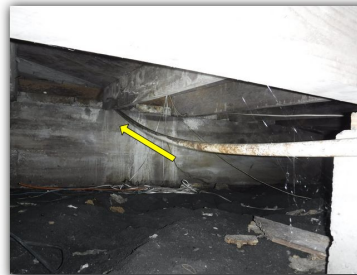
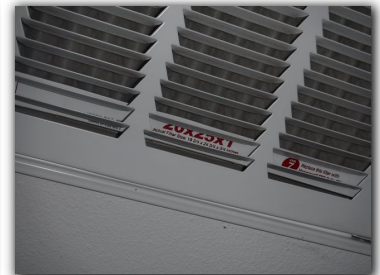
- This component appears to be performing adequately at the time of this inspection. It is achieving an operation, function, or configuration consistent with accepted industry practices for its age.
- The condensate drain line in crawl space is pitched upward and not down at all points.
- The primary condensate drain line is not equipped with a p-trap. Under current mechanical installation standards, the manufacturer requires a p-trap be installed in the primary condensate drain line within 6-inches of the coil housing.
- Note:** The primary condensate drain line is terminated next to the exterior foundation perimeter beam. It is recommended that the drain line terminate further away from the foundation beam or to an approved waste system.

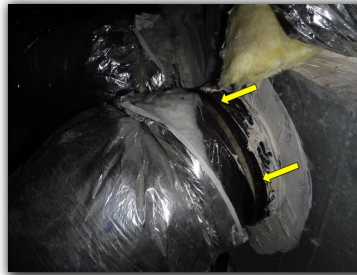
- The duct system was observed to be dirty and needs to be cleaned for air quality purposes.
- The return air register in laundry and exterior door is poorly located. Recommend return be in hallway area of home and away from exterior doors or next to window openings.
- Some areas of duct work insulation need re-secured in attic space.
- **Note:** An air leakage test is not performed and is beyond the scope of a general home inspection, to verify any potential compromises in duct work running through attic or between walls.

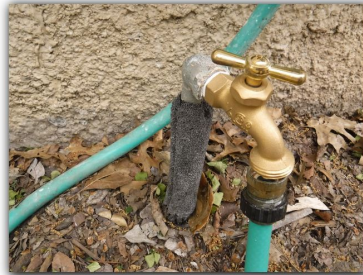
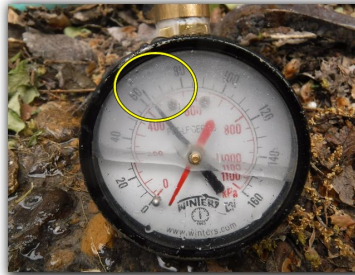
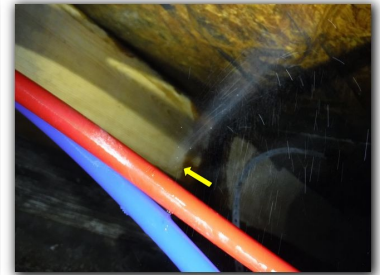
- One or more of the exterior water hose bibbs (faucet) do not have a back-flow or anti-siphon device (Vacuum Breakers) in place. **Note:** *This is not uncommon to observe with a home of this age.*

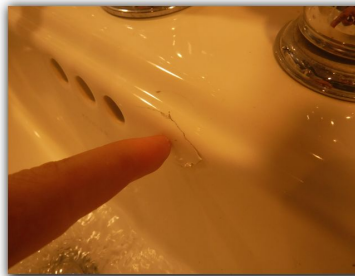
- Chipped or damaged interior sink at guest bathroom observed.
- The guest bathroom toilet seat does not remain up but falls and adjustment is needed.
- The shower diverter is not properly engaging for shower function at time of inspection in master bathroom. Recommend adjustment or corrective measures as needed.
- Leaking of the Pex line below guest bathroom observed in crawl space. Recommend further evaluation and corrective measures as needed by licensed plumber.

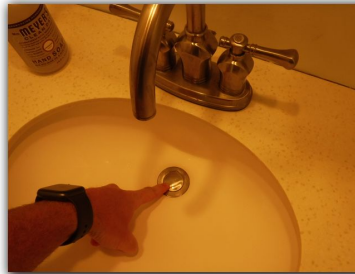
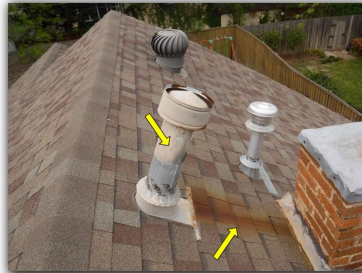
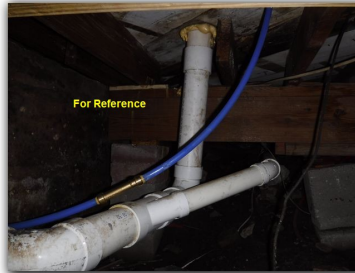
- The drain plug at guest bathroom sink/basin did not engage properly to hold water. Recommend adjustment or further evaluation as needed.

**Notice:** There was cast iron piping in place. Cast iron drain piping has an expected useful life or life span in this region of approximately 40-60 years. All drains operated as intended, but recommend lateral sewer scope inspection by licensed plumber if needed to determine if additional issues are not visible.

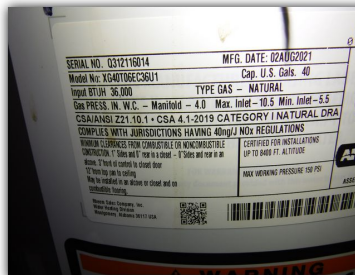
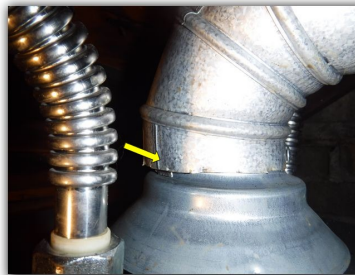
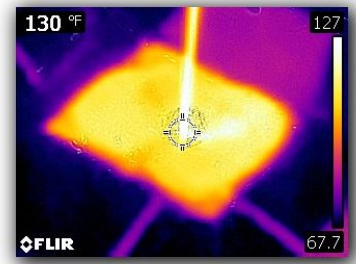
- The flue should be attached to top of water heater with three (3) sheet metal screws.
- Flue strapping needed in attic to secured between rafters.
- The water heater gas supply line is not equipped with a sediment trap just before the gas appliance connector. This condition does not meet current installation requirements.

- The temperature and pressure relief discharge pipe is terminating into the water heater drain pan. Under current building standards, this discharge pipe should run downward to the exterior of the structure, turn downward, and terminate within 6-inches of the ground.

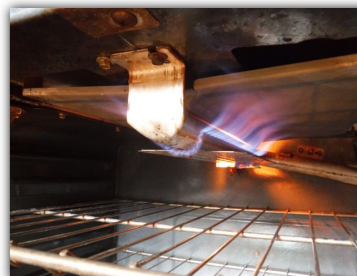
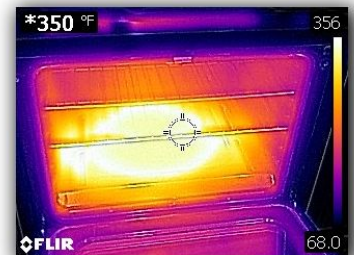
**Anti-tip device:** Not present (does not meet today's standards)

- The temperature of the oven was checked at 350 degrees and rose to 350 degrees, holding that temperature. This meet's today's standard range of 325-375°F.
- The range can be easily tipped over and should be equipped with an anti-tip device, for safety.
- Some delamination of the display for range controls observed.

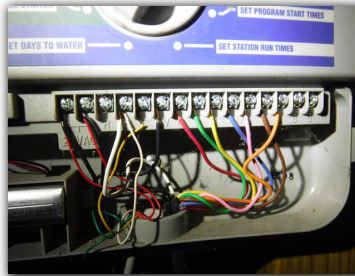
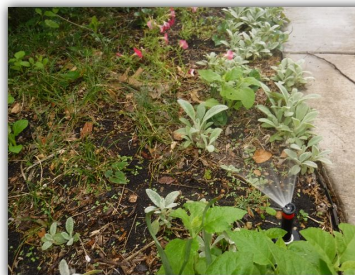
- This component appears to be performing adequately at the time of this inspection. It is achieving an operation, function, or configuration consistent with accepted industry practices for its age.
- Inadequate pressure observed in zone 3 of the system. Recommend further evaluation and correction of this zone or it's related heads as needed.
- There was no activity to sprinkler head in zone 1 along side yard and back yard in zone 5.

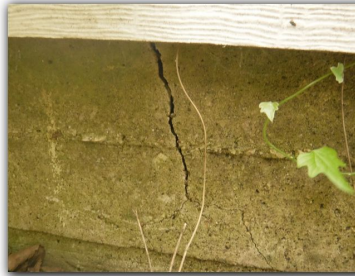
- Cracks were observed in the floor of the foundation.
- Floor slopes and/or unlevelness were observed.
- Stress crack(s) were observed in the exterior foundation perimeter beam.

The foundation appears to have had movement that may be beyond normal. A Professional Engineer licensed by the State of Texas or qualified foundation repair company/specialist should be consulted on the current integrity of the foundation and any repairs that may be necessary (if any). The observations made to support the rendering of this opinion are listed but not limited to the following:

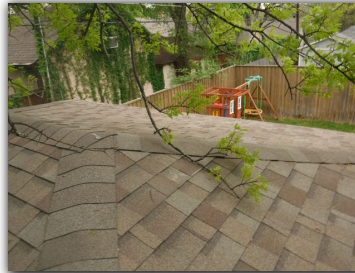
- Some granular loss damage observed to roof shingles, likely due to tree contact.
- Tree and shrub branches need to be trimmed away from the roofing material at all times to help prevent damage to the roofing material. It is the opinion of this Inspector that there are some branches too close to the roofing material at this time and corrective measures are needed.
