**Cliff Burton**  
4567 Bass Slap Dr.  
Midlothian, TX 76065

**March 10, 2025**

# PROPERTY INSPECTION REPORT FORM

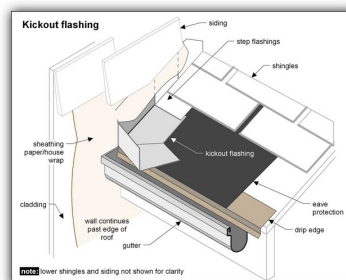
- Some loose drip edge flashing along SW corner of roof.
- There was no kickout flashing details observed at the lower bottom edge of the roof line interface and the sidewall that continues past the edge of the roof. The lack of this kickout flashing may allow water to penetrate at these points.

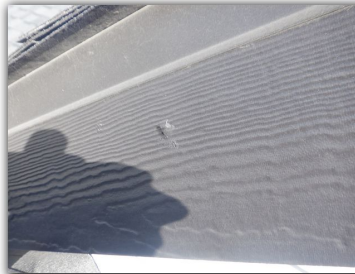
- Opening under eaves observed along south side of structure while walking roof. Recommend correction and sealing area as needed.
- The fascia board ends are in contact with roof covering at time of inspection in one or more locations. This does not meet today's standards requiring at least a 1" separation to prevent water damage or absorption.
- Nail head exposed along upper south side fascia while walking roof.

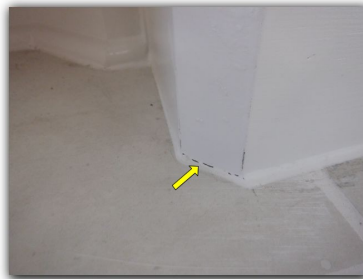
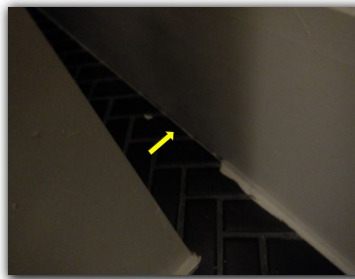
- Some areas of re-sealing baseboards to tile needed in bathrooms.
- Sealant not installed along baseboards meeting tile in powder bathroom.

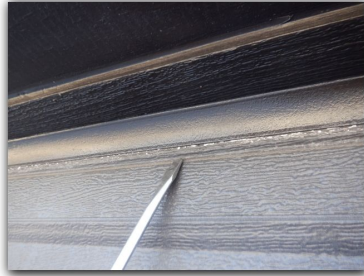
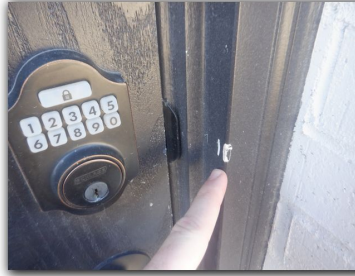
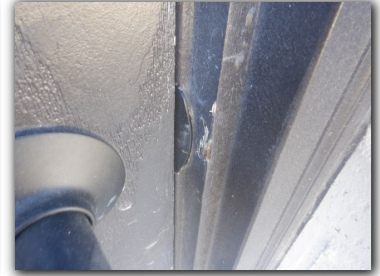
- The garage entry door is not equipped with a self-closing device. Under current building standards and TREC standards, this is now a requirement.
- Chipped paint along north exterior door needs re-painted/repared.
- Painting along top of overhead door needed.

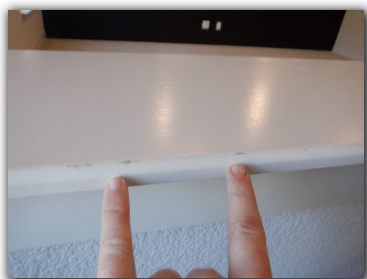
- Touch up painting needed at upper pony wall top.

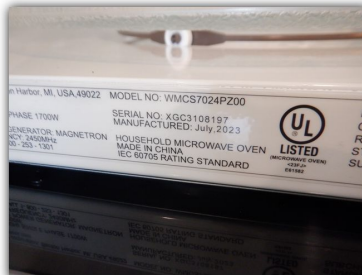
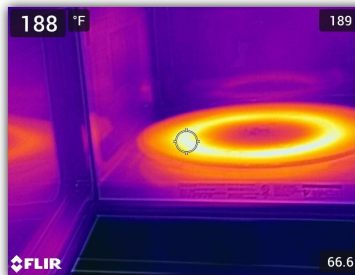
- This component appears to be performing adequately at the time of this inspection.

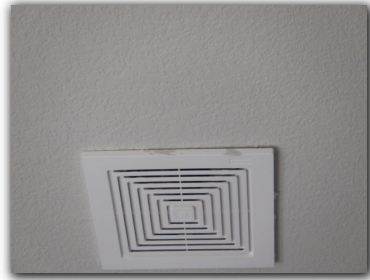
- This component appears to be performing adequately at the time of this inspection.
- Clean paint on mechanical exhaust cover in master bathroom.

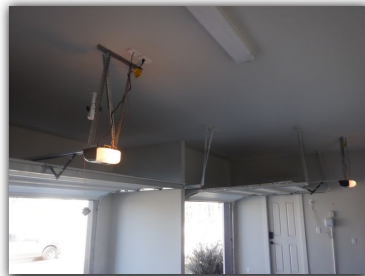
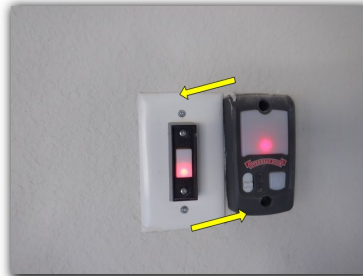
- This component appears to be performing adequately at the time of this inspection.
- The openers along wall off garage entry door are reversed, far button controlling opposite side overhead door.
