**Lincoln Hawk**  
407 Trucker St.  
Richardson, TX 75081

**April 21, 2025**

# PROPERTY INSPECTION REPORT FORM

Lincoln Hawk <i>Name of Client</i>	04/21/2025 <i>Date of Inspection</i>
407 Trucker St., Richardson, TX 75081 <i>Address of Inspected Property</i>	
Ryan Cantrell <i>Name of Inspector</i>	21398 <i>TREC License #</i>
 <i>Name of Sponsor (if applicable)</i>	 <i>TREC License #</i>

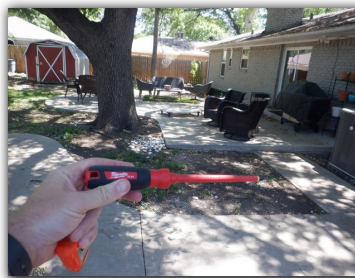
- The gutter downspouts should discharge water at least thirty-six inches (36") away from the foundation perimeter beam. Storm water should be encouraged to flow away from the structure at the points of discharge.
- Minor leaks in the gutter joints and seams should be repaired.
- The gutters require cleaning in one or more areas.
- Kick out missing at lower end of downspout needs installed along west side of home.

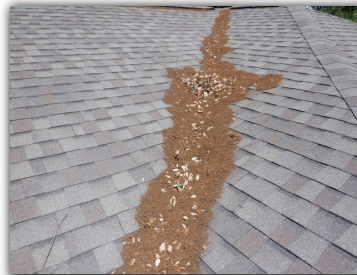
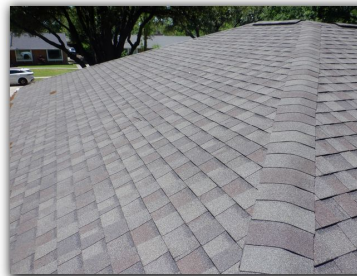
- Damaged shingles observed due to overhanging tree limbs or branches in contact with roof covering. Recommend keeping all vegetation or tree limbs/branches cut back.
- The felt paper was observed to be installed under the lower metal drip edge flashing detail. The manufacturer installation requires the felt paper to be installed over the top of the metal drip edge flashing, in shingle like fashion, to help prevent water intrusion and/or damage to occur behind the fascia board and soffit/eave areas.
- **Note:** All debris, such as leaf's and branches, should be removed from the roof structure.

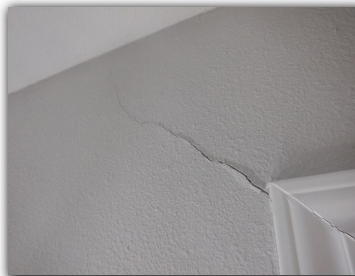
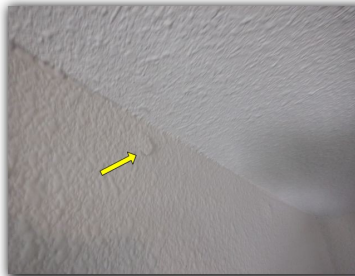
- Cracked tiles in guest shower area over faucet.
- Nail heads were observed to be pushing through the interior finish in one or more locations.
- Stress cracks observed in sheet rock/drywall in one or more areas of home, including (but may not be limited to) bedrooms and bathroom door openings. Recommend monitoring all cracks over time or repairing as needed.

- Interior wall joint cracks (at tape and bed joint of drywall) were observed in one or more bedrooms over doorways. Recommend monitoring all cracks over time or patching/painting as needed.

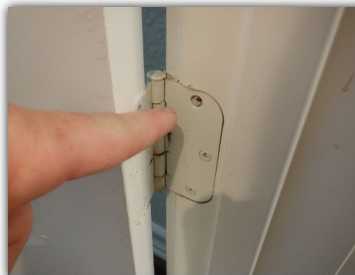
- One or more hinge screws missing at interior doors.
- The back hallway close door does not fit properly within framing.

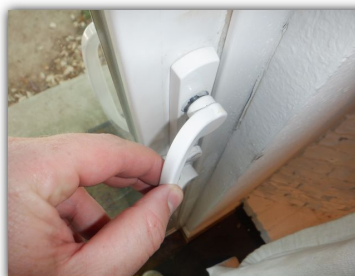
- Sliding glass door off west master bedroom area does not latch/close properly.
- Loose handle to one or more sliding glass doors observed.

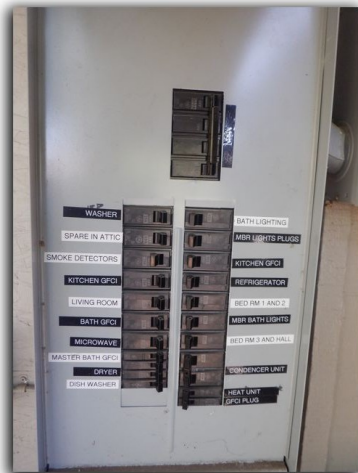
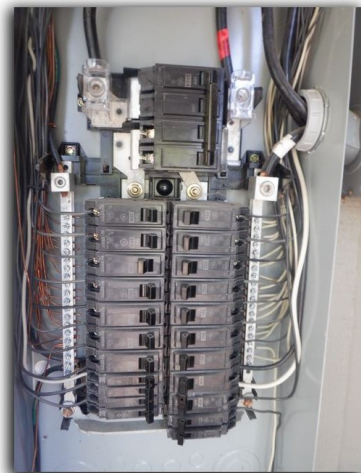
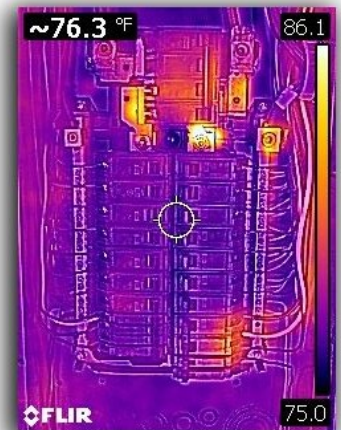
- Unmarked white wires have been used for "hot" 240 volt circuits that are not currently identified in the breaker panel. When white wires are used in this capacity the installer should indicate the wire as "hot" with a black designation i.e. electrical tape/black markings. This is a common issue in panels of all ages.

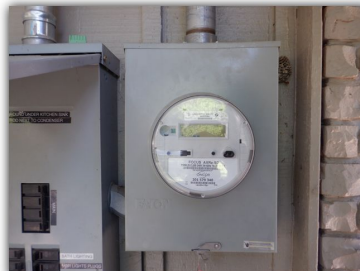
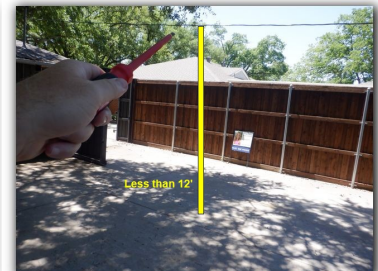
- The electrical service wires hang to low across the back yard area. The electrical service wires from the service pole to the structure should clear the driveway by a minimum of 12-feet.

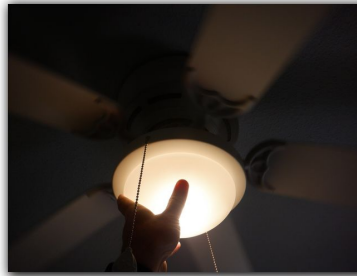
- One or more closet lights were observed without covers/diffusers. This does not meet today's current standards.
- One or more light bulbs in fixtures were observed to be burned out and in need of replacement or further evaluation as needed. These fixtures include (but are not limited to) the bathroom vanity lights.
- Master bedroom ceiling fan is hardwired and no visible switch in area to operate. This configuration does not meet today's electrical standards.
- One or more wobbly ceiling fans need adjustment, correction and balancing.

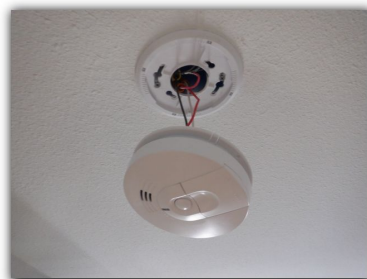
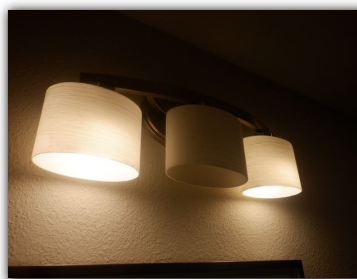
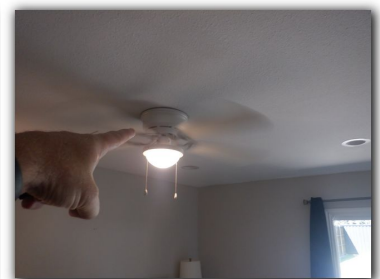
- **Note:** Due to location, height or conditions outside the control of the inspector, one or more of the smoke/carbon monoxide alarms were inaccessible and could not be tested at the time of this inspection. It is always recommend to verify and check the status of smoke/carbon monoxide detectors within the home.
- **Note:** It is recommended to replace the batteries in all of the smoke detectors once a year for reasons of safety.
- **Note:** The breaker for smoke detectors was OFF at time of inspection.
- An audible sound can be heard from one or more of the smoke detectors, indicating that the batteries need to be changed. It is recommended to replace the batteries in all of the smoke detectors once a year for reasons of safety.
- One or more loose smoke detectors need re-secured at ceiling.
- One or more missing smoke detectors in bedrooms need installed.

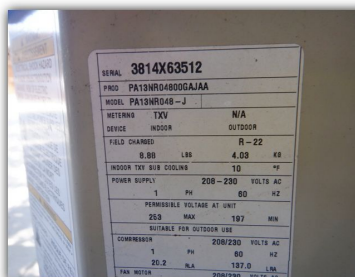
- The system was operating for over 30 minutes and ambient temperature did not drop below beginning temperature of 74°F. Recommend further evaluation by licensed HVAC technician of the system or thermostat as needed.
- Leaking in the past observed around condensate line at unit.

This cooling system and equipment needs to be checked and serviced by a Qualified / Licensed HVAC Company. The observations made to support this opinion are listed but may not be limited to the following:

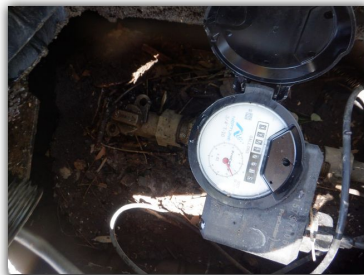
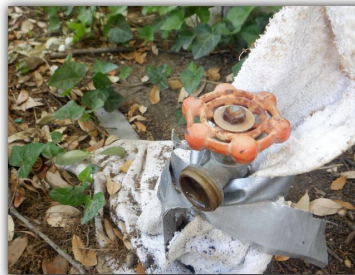
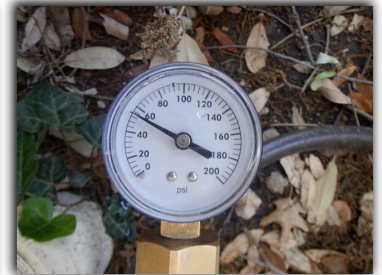
##### Water Supply & Exterior Faucets/Fixtures:

- One or more of the exterior water hose bibbs (faucet) do not have a back-flow or anti-siphon device (Vacuum Breakers) in place. **Note:** *This is not uncommon to observe with a home of this age.*

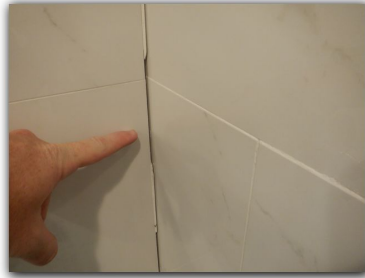
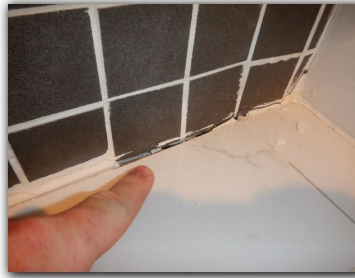
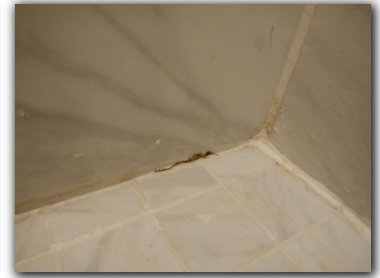
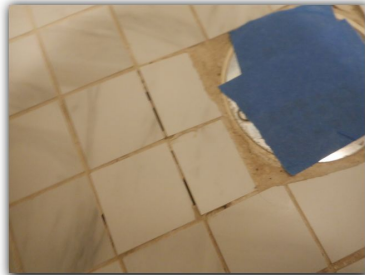
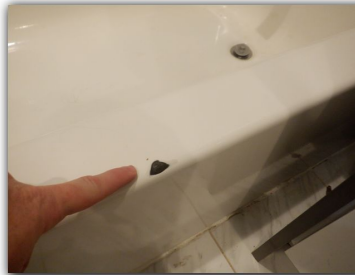
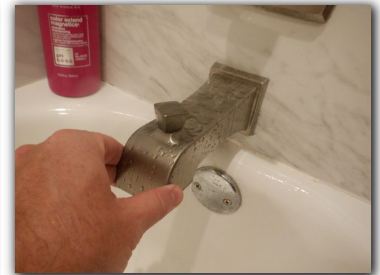
- Loose west side master bathroom faucet in tub area needs re-secured.
- Multiple areas of re-sealing needed in shower tile areas where grout compromises were observed.
- Surface damage to guest bathtub observed (porcelain chipped).
- Re-grouting the floor of one or more shower tile areas.
- Loose kitchen faucet needs re-secured.

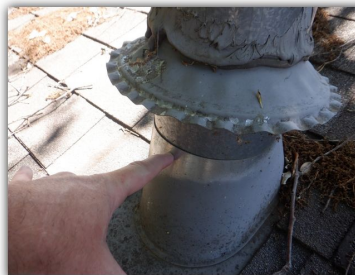
**Exterior Vents:**

- Vents were observed by: Walked on Roof
- Collar at furnace flue should be adjusted (moved down) at flue connection.
- One or more dent's or ding's observed to gas b-vent termination caps at roof.
- Missing yard clean out in back yard needs installed, posing trip hazard.

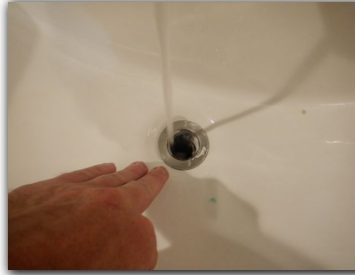
#### Kitchen & Bathroom Drains:

- Missing drain plug to master bathroom sink observed.
- The drain plug at guest bathroom sink/basin did not engage properly to hold water. Recommend adjustment or further evaluation as needed.
- **Note:** One or more lower cabinets observed with previous water staining or damage in bathrooms. While no active or current leaks were detected, recommend monitoring over time.

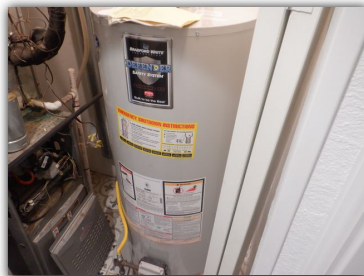
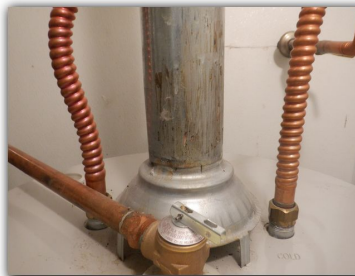
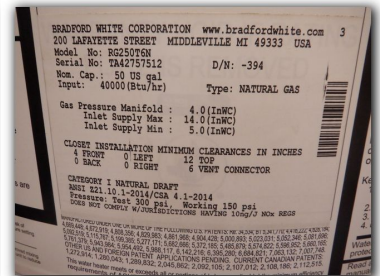
- This component appears to be performing adequately at the time of this inspection. It is achieving an operation, function, or configuration consistent with accepted industry practices for its age.
- The flue should be attached to top of water heater with three (3) sheet metal screws.
- There is no expansion tank in place, now required when irrigation system is present.
- **Note:** The temperature and relief valve was not tested at time of inspection due to possibility of leaking or damage to property.

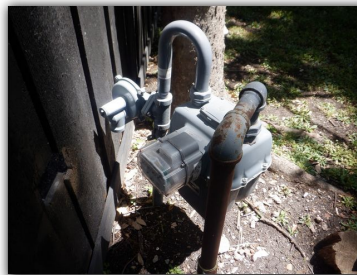
- This component appears to be performing adequately at the time of this inspection.
- There is no bonding clamp at meter, which may not have been required at time of build but no longer meet's today's standards where no visible and present.

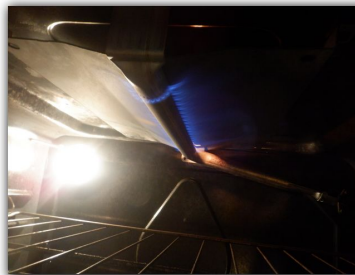
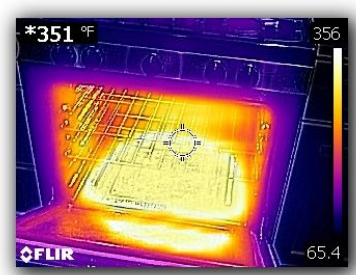
- The temperature of the oven was checked at 350 degrees and rose to 351 degrees, holding that temperature. This meet's today's standard range of 325-375°F.
- The range can be easily tipped over and should be equipped with an anti-tip device, for safety.

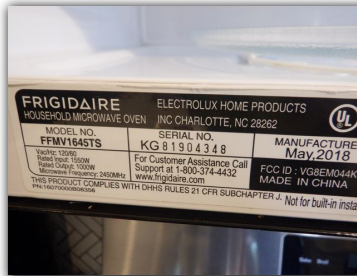
#### E. Microwave Ovens

- This component appears to be performing adequately at the time of this inspection.
- Deteriorated coating around microwave door observed.

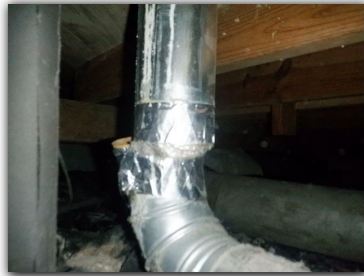
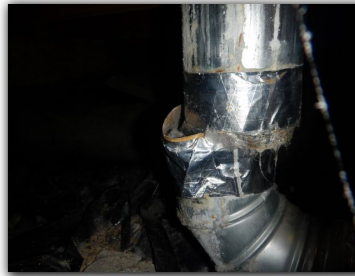
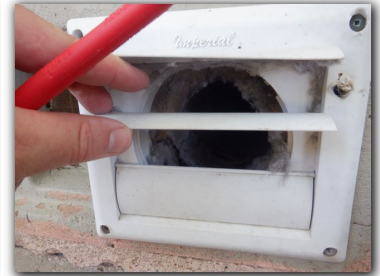
- The dryer duct is separated in the crawl space area.

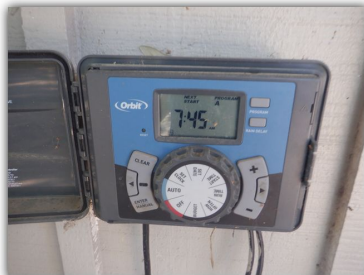
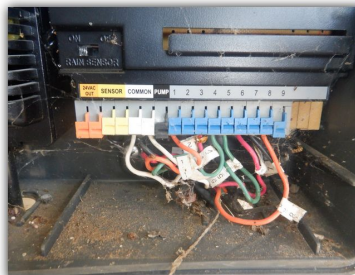
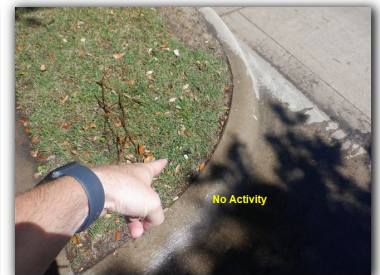
- This component appears to be performing adequately at the time of this inspection. It is achieving an operation, function, or configuration consistent with accepted industry practices for its age.
- No activity at sprinkler head near curb off driveway in zone 1 observed.
- I was unable to locate a moisture (rain / freeze) sensor device for the sprinkler system. This is an **"as-built" condition**, but Per TREC standards of practice we are required to report this condition as a deficiency.

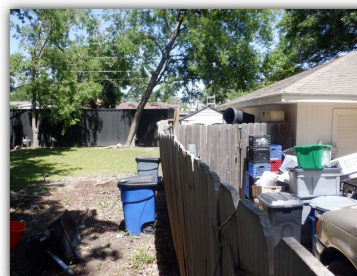
#### D. Fences

- One or more portions of the east side fence are out of vertical alignment and leaning. Recommend adjustment/repair or further evaluation as needed.
